Reusco, Inc. dba Housemaster

Inspection Date: 9/23/2005

## INSPECTION INFORMATION

sample  
Pittsburgh, Pa

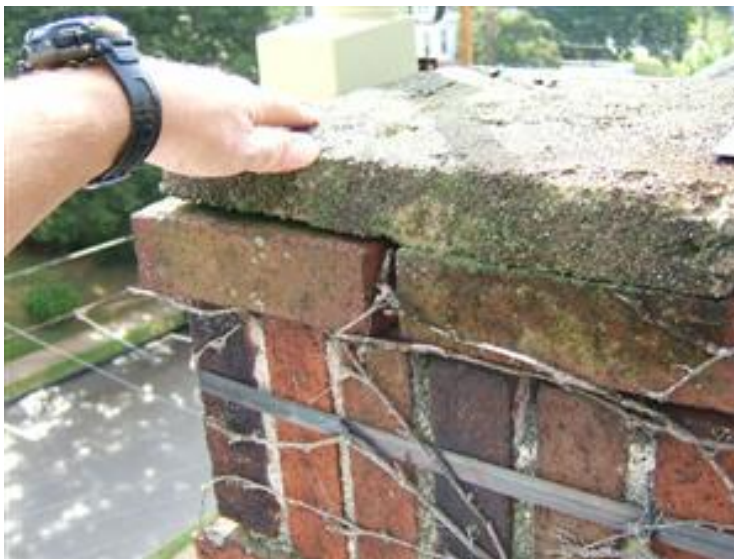
1.1 CHIMNEYS / VENTS Picture 1

| | | ● | | | | 1.1 | <b>CHIMNEYS / VENTS</b><br>Cracked mortar cap/crown noted; recommend seal and maintain as required. Review mortarwork/cap supplemental information. Mortar deterioration noted , loose/ damaged/ missing bricks noted, Recommend re-pointing as needed by qualified contractor. |

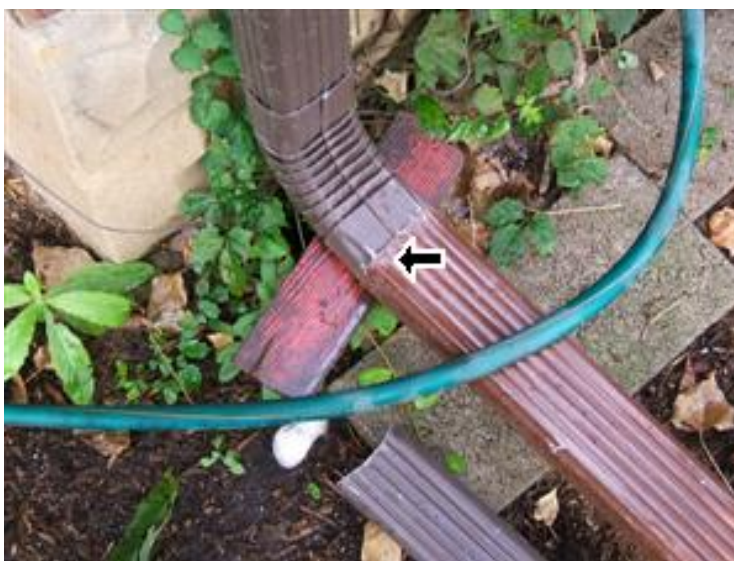
1.8 DOWNSPOUTS / ROOF DRAINS Picture 1

| | ● | | | | | 1.8 | <b>DOWNSPOUTS / ROOF DRAINS</b><br>Leakage noted at front corner fitting; Repair as needed. |

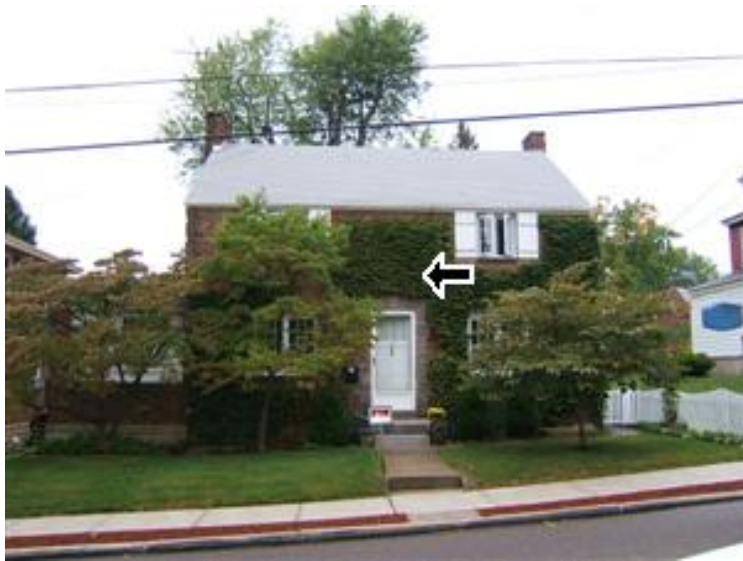
2.0 SIDING Picture 1

| | | | | ● | 2.0 | <b>SIDING</b><br>Siding covered with vegetation at many all areas; conditions indeterminate in these areas. |

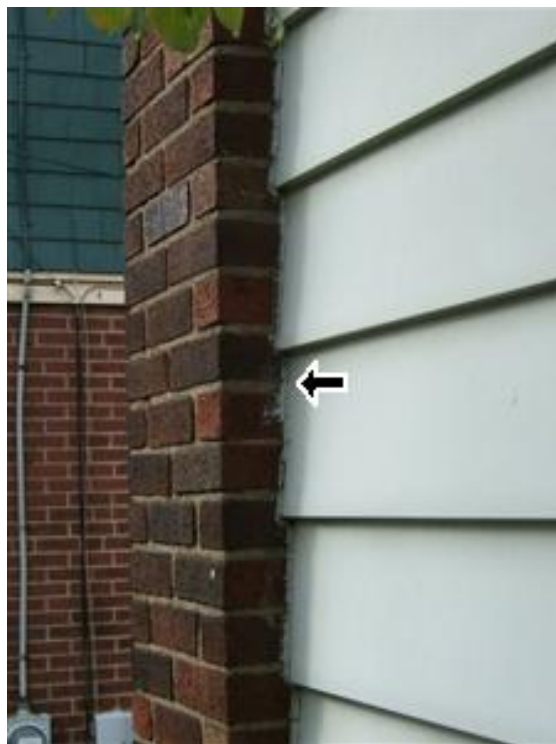
## 2.1 Siding 2 Picture 1

| | ● | | | | 2.1 | <b>Siding 2</b><br>Worn or missing caulking in need of maintenance at some areas, Recommend repair or replacement as needed. |

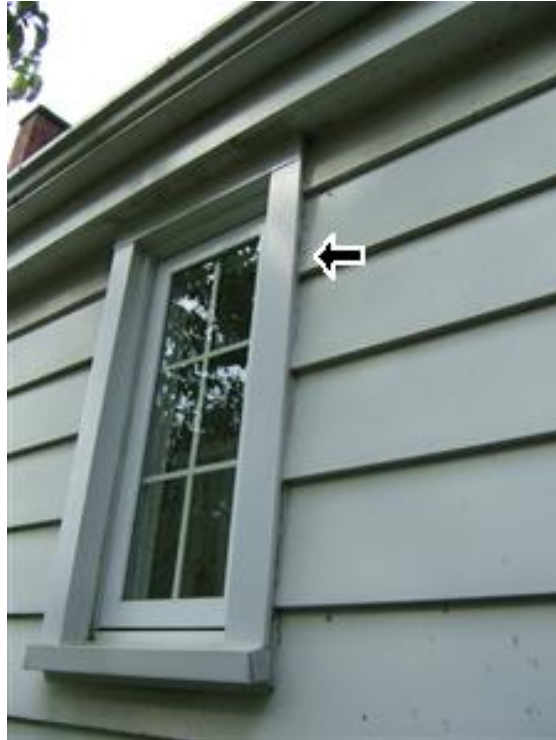
2.2 WINDOWS Picture 1

| | ● | | | | 2.2 | <b>WINDOWS</b><br>Worn or deteriorated/cracked caulking noted at some areas; Recommend repair of all as needed by a qualified contractor. |

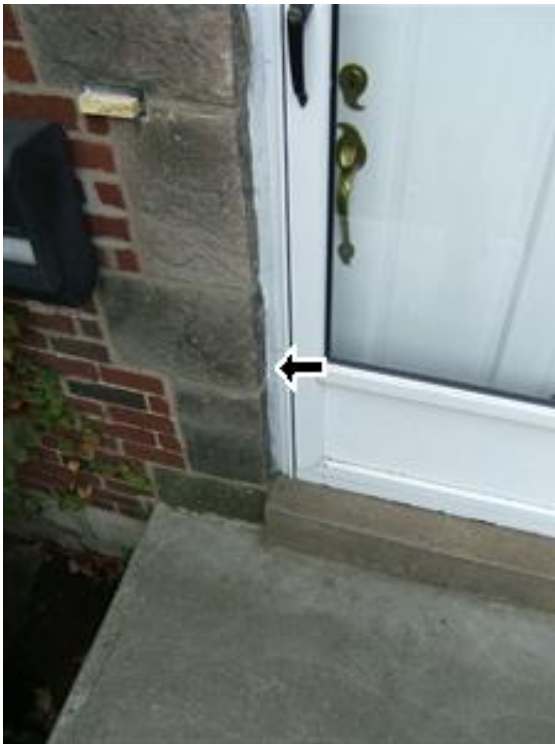
2.3 ENTRY DOORS Picture 1

| | ● | | | | 2.3 | <b>ENTRY DOORS</b><br>Cracked/Deteriorated or worn caulking at front door; Recommend replacement/Repair of caulking/sealant. |

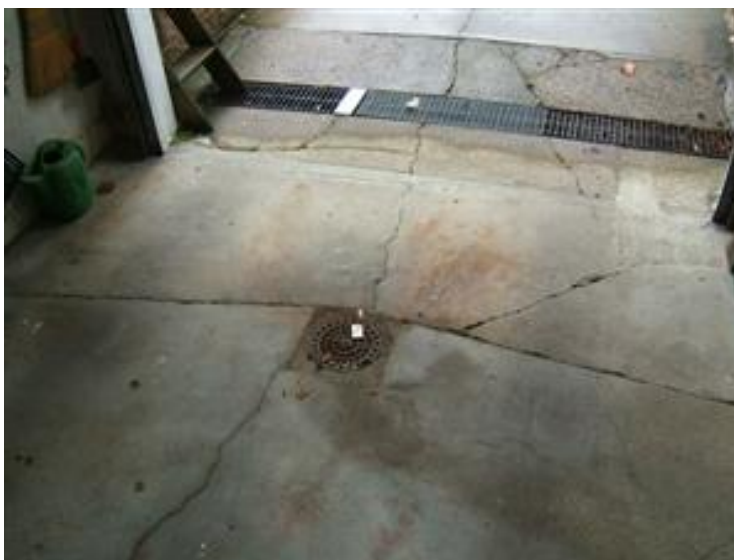
4.2 FLOOR SLAB Picture 1

Floor is heavily cracked/settled ; recommend repair/replacement by a qualified contractor.

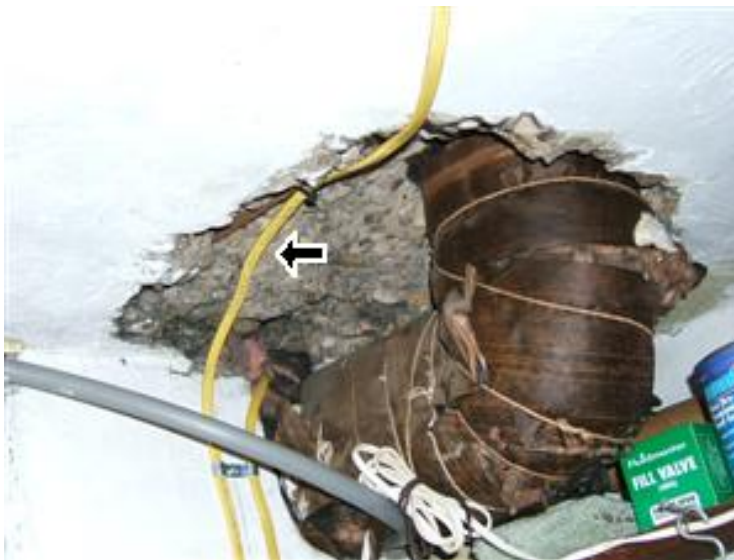
4.5 WALLS / CEILINGS Picture 1

Concrete ceiling noted (slab of the addition), missing materials noted at the front corner that were removed for the heating duct. Repair as desired.

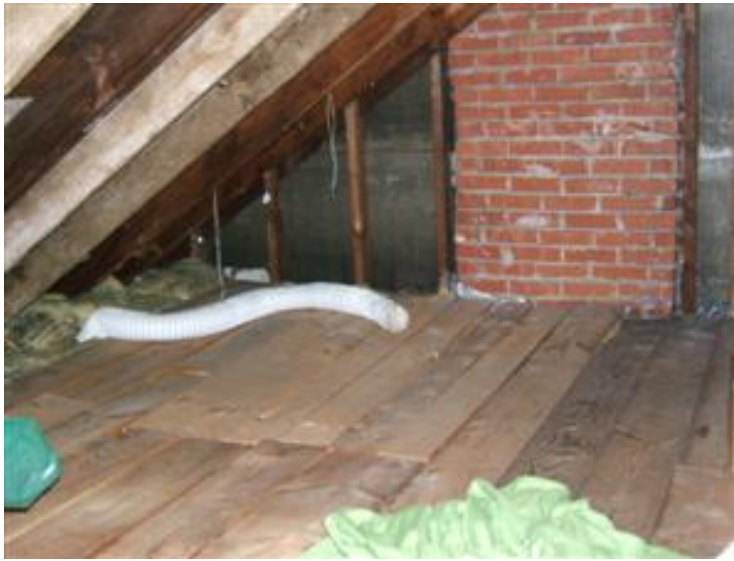
5.2 VENTILATION PROVISIONS Picture 1

Exhaust vent from bathrooms vent directly to attic area, not recommended practice. May lead to mold growth. Recommend venting directly to the exterior as required.

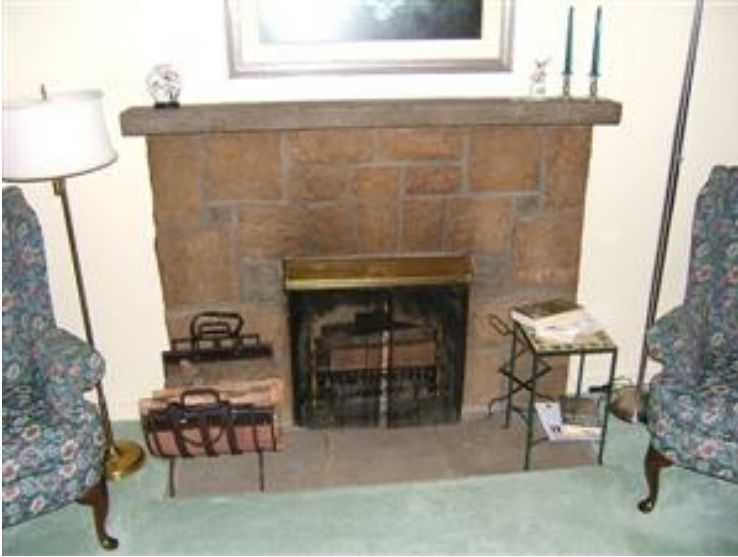
8.9 FIREPLACE(S) Picture 1

Visual inspection of firebox and damper area only, a standard home inspection does not include drafting or NFPA inspections on any level. Review supplemental information titled fireplace/chimneys. Loose firebrick noted; recommend repair or re-pointing by a qualified contractor. Review supplemental information titled firebox in Fireplace section. Substantial creosote buildup noted. No evaluation of interior components possible. Have unit cleaned and serviced prior to use. Mortar gaps or hollow bricks noted, Recommend proper sealing of these areas by a qualified contractor. If the hollow bricks are present in the throat or smoke chamber, it is required that the area be parge coated smooth. It appears the smoke chamber has been made smaller by the addition of some stone and firebrick.

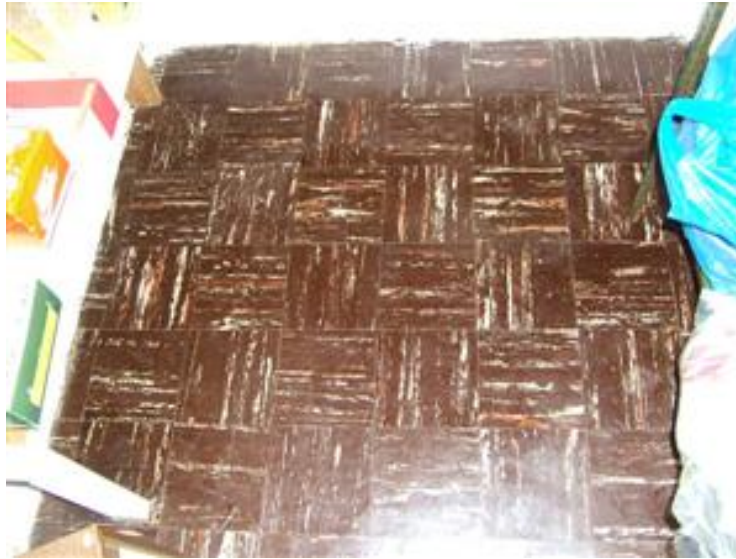
9.4 BASEMENT FLOOR (SLAB) Picture 1

Typical cracking noted. Monitor and correct as desired. Older 9"x9" floor tiles noted, Due to age it may be an asbestos containing product, Review supplemental information titled ACM insulation.

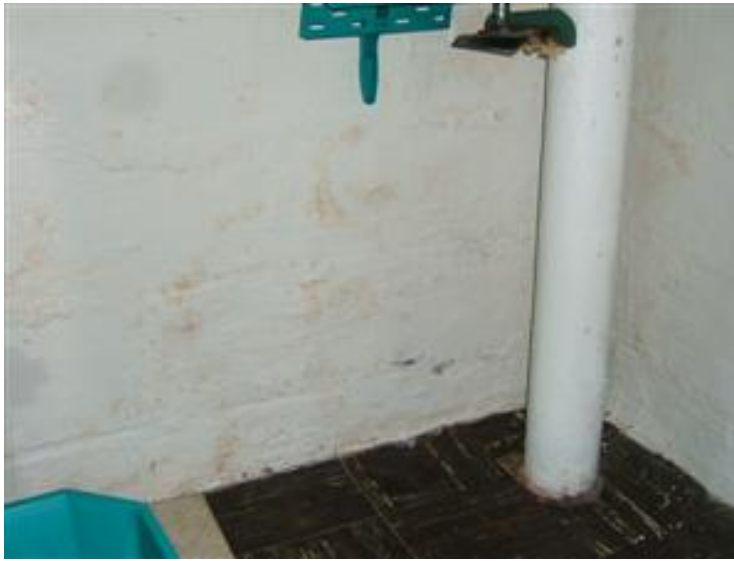
10.1 INTERIOR CONDITIONS Picture 1

Report comments are based on conditions observable at the time of inspection; it is not possible to accurately determine the extent of any past conditions or to predict future conditions or concerns. Water stains noted at basement; indicative of leakage from the exterior. Review comments in exterior and site grading sections of report and repair or replace elements as needed.

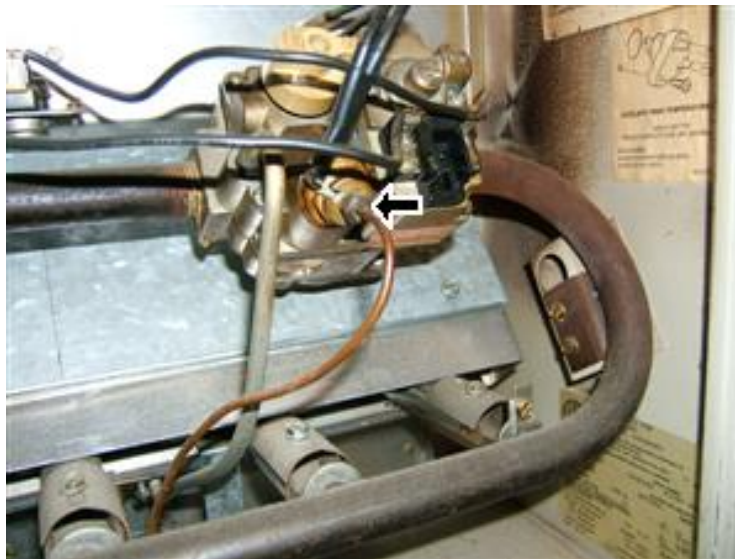
13.2 GAS / FUEL LINES AT UNIT Picture 1

Leak detected at the control box ; Recommend repair by a qualified contractor.

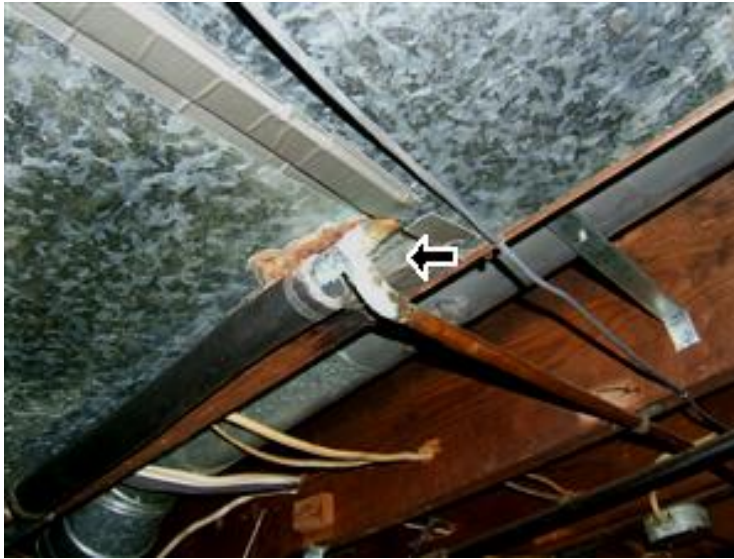
14.0 WATER PIPING Picture 1

Corrosion noted at joints and valves, Repair as needed Galvanic action noted at water line that is touching the return air ductwork (opposing metal) recommend repair or replacement of damaged pipes. Incoming line was possibly lead (limited visibility due to painting of line and walls, Monitor and correct as future conditions warrant. Many missing shut off valve handles, Replace as needed.

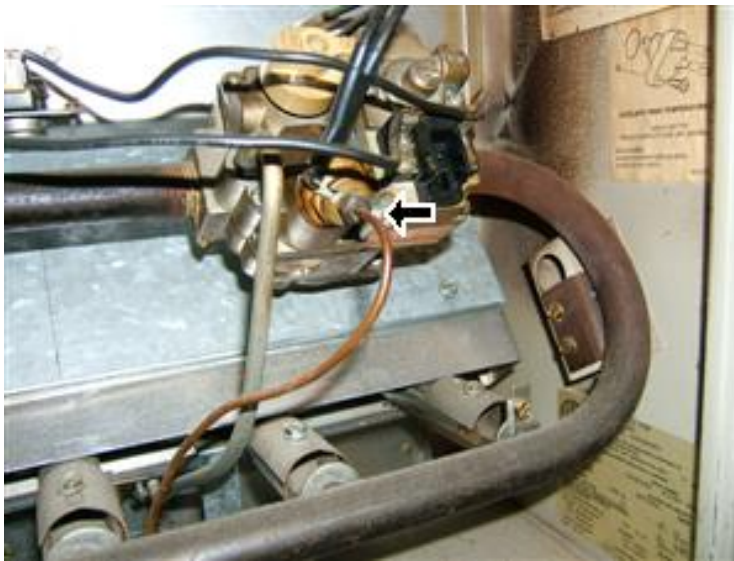
14.7 GAS PIPING Picture 1

Leakage detected at fitting at the furnace; repair as required.

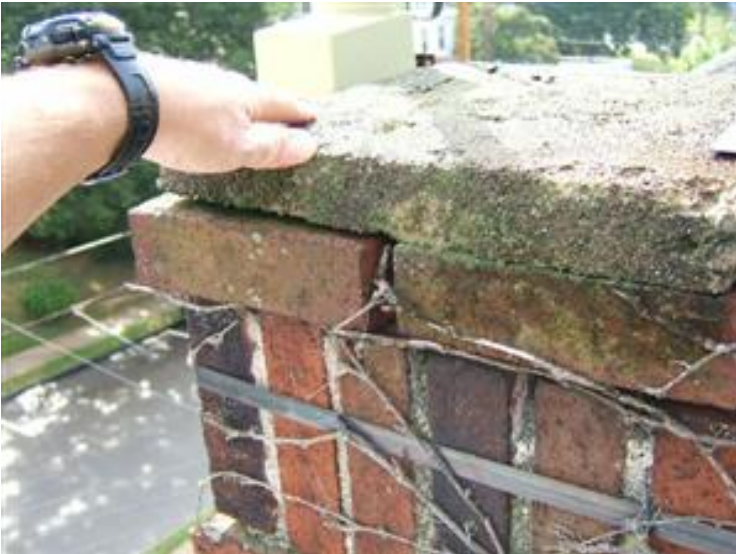
1.1 Picture 1

Cracked mortar cap/crown noted; recommend seal and maintain as required. Review mortarwork/cap supplemental information. Mortar deterioration noted, loose/ damaged/missing bricks noted, Recommend re-pointing as needed by qualified contractor.

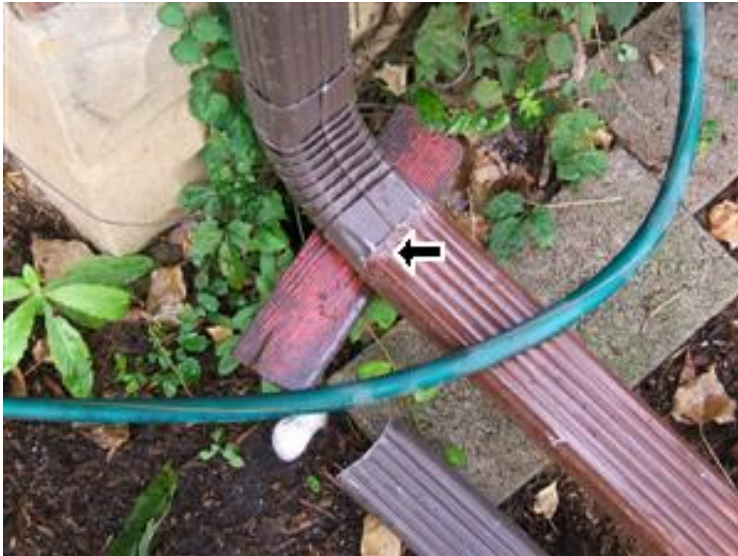
1.8 Picture 1

Leakage noted at front corner fitting; Repair as needed.

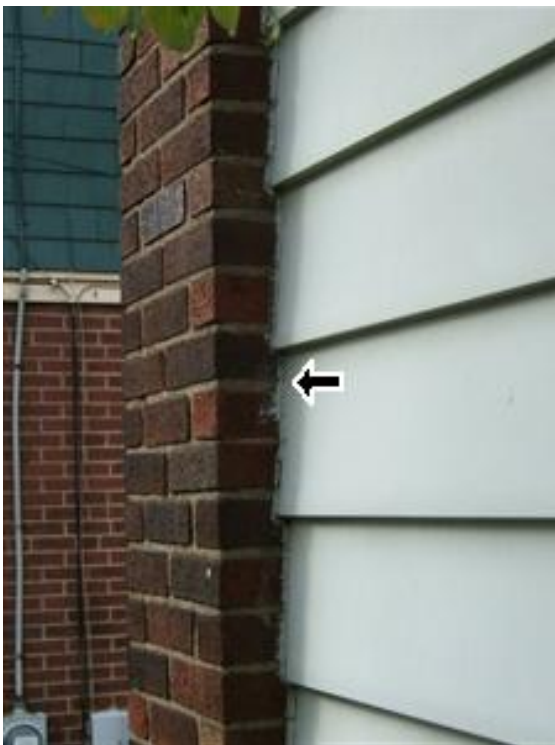
2.1 Picture 1

Worn or missing caulking in need of maintenance at some areas, Recommend repair or replacement as needed.

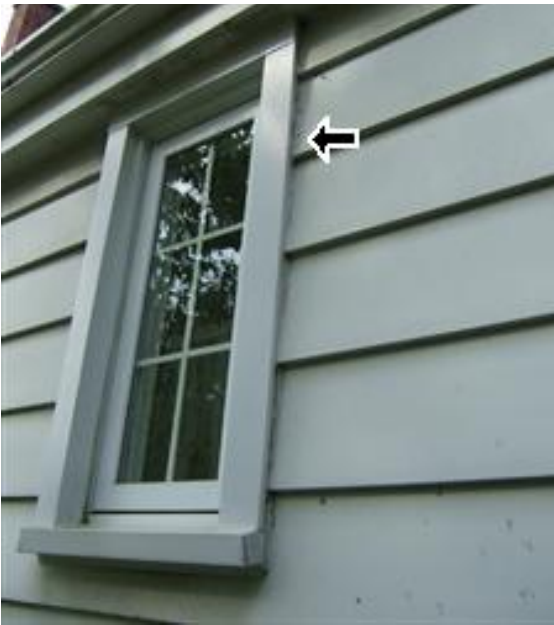
2.2 Picture 1

Worn or deteriorated/cracked caulking noted at some areas; Recommend repair of all as needed by a qualified contractor.

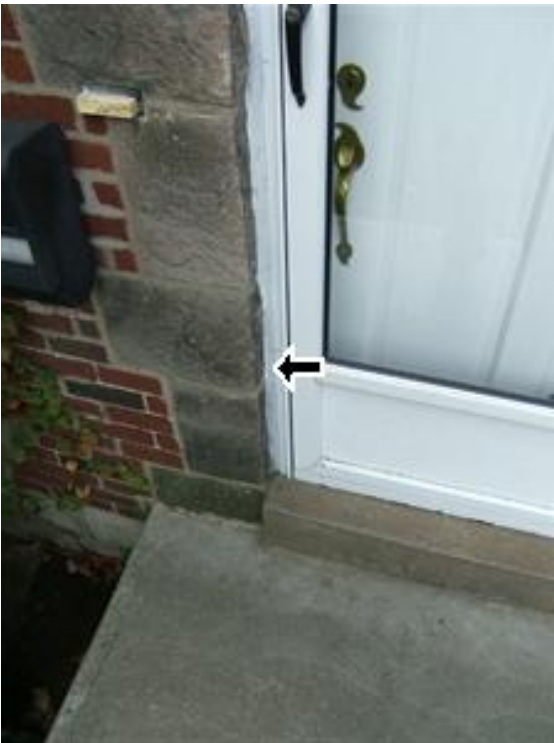
2.3 Picture 1

Cracked/Deteriorated or worn caulking at front door; Recommend replacement/Repair of caulking/sealant.
