Report ID: THIS IS SAMPLE REPORT ONLY

Property Address:  
123 Anywhere Street  
Chapel Hill, NC 27517

Cornerstone Home Inspection Service, LLC dba HouseMaster  
Inspector: C. Garrett "Garry" Walker III NC LIC # 1551

1289 N. Fordham Blvd  
Suite A-109  
Chapel Hill NC 27514  
919-403-9675  
Inspection Date: 3/12/2007

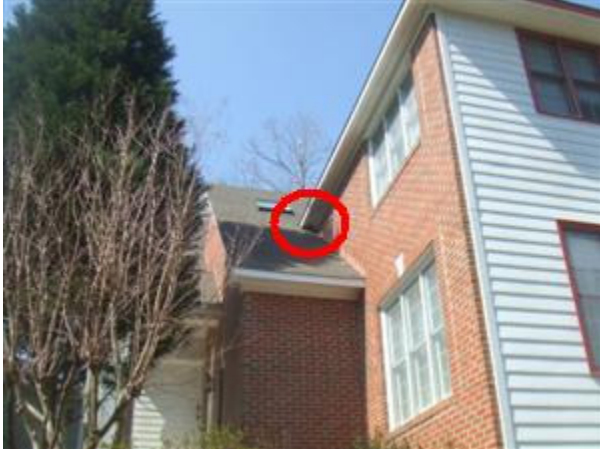
1.1 Picture 1

Fascia board and Soffit deteriorated and may have water penetration. Further water penetration and/or damage will occur. Correct cause of damage and Repair/replace using a qualified contractor at front below skylight.

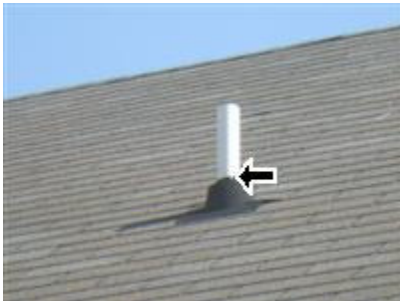
1.2 Picture 1

Plumbing stack boot (s) damaged at all roof locations. Currently allowing water penetration. Review all and Repair/replace using a qualified contractor

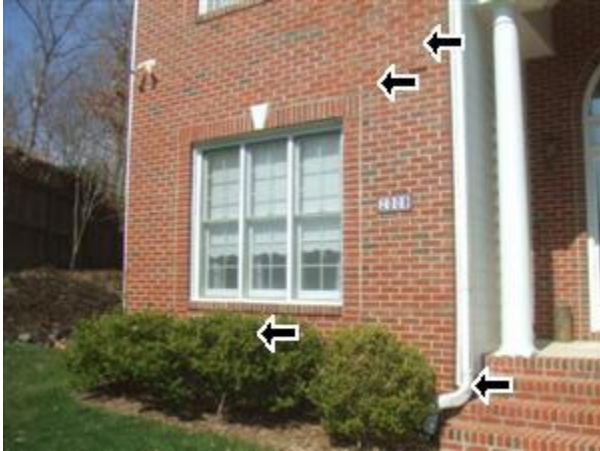
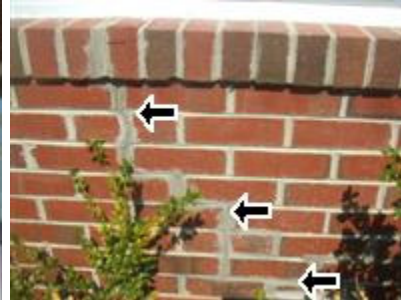
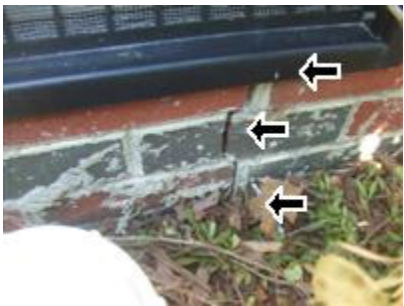
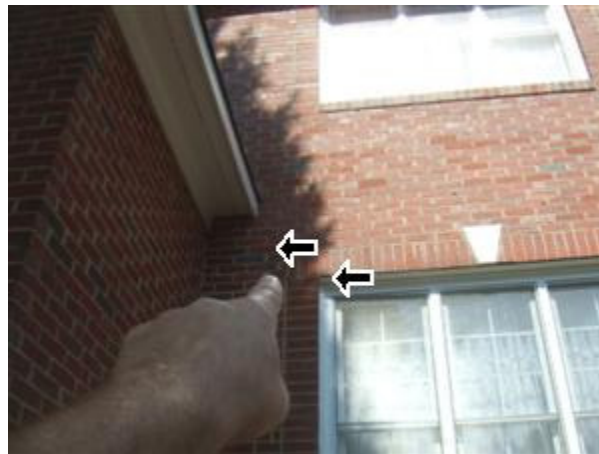
1. Brick siding cracked (horizontal) , cracked (step crack). Further movement is possible. Ask owner about repairs and obtain receipts/documentation and Conditions warrant further investigation by a **qualified/licensed structural engineer** and repair as directed at front main level bedroom. May have been from water penetration at window sill or main water and waste line entry in crawlspace. ( Picture 1 ) ( Picture 2 ) ( Picture 3 )
2. Brick siding cracked (step crack). Further movement is possible. Conditions warrant further investigation by a **qualified/licensed structural engineer** and repair as directed at front above dining room window.( Picture 4 ) Note movement in window and wall at interior areas of front dining room.

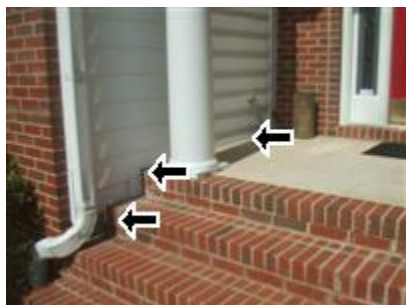
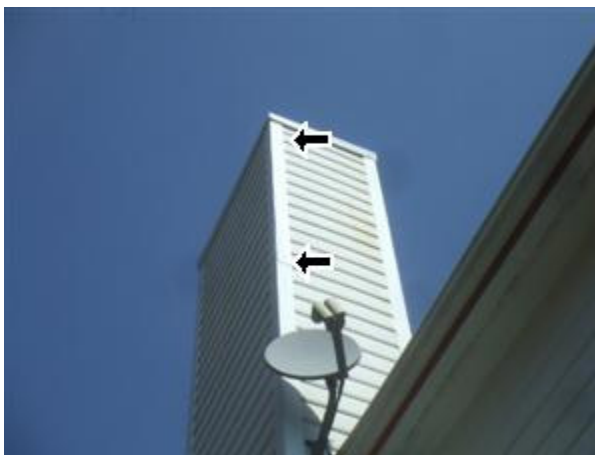
1. Lapped siding has signs of prior repairs. This is for your information. Ask owner about repairs and obtain receipts/documentation at left side of front covered porch, chimney corner boards.( Picture 1 )
2. Corner board (s) decayed. Will allow water penetration. Repair/replace using a qualified contractor at left front corner of chimney near top.( Picture 2 )

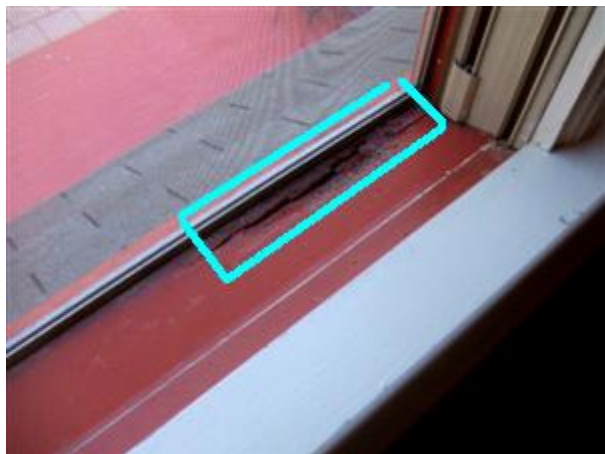
2.2 Picture 1

1. Window trim decayed. Further deterioration may occur if not repaired. Conditions warrant further investigation by a **qualified/licensed general contractor** and repair as directed at front main level bedroom wall.

2. Window sill tilted inward (improperly installed). Will allow water penetration which can cause damage/deterioration to building components. Conditions warrant further investigation by a **qualified/licensed general contractor** and repair as directed at front main level bedroom. See Exterior siding as this may have been cause of settlement cracks.

3. Window frame and trim , sill peeling paint. Deterioration may occur if not corrected. Prep, prime and painting of materials is required at all exterior windows.

4. Window sill damaged , decayed. Because of the extent of deterioration it is possible for some framing in wall to be deteriorated and conditions behind materials is indeterminate . Conditions warrant further investigation by a **qualified/licensed general contractor** and repair as directed at left rear 2nd floor bedroom window.

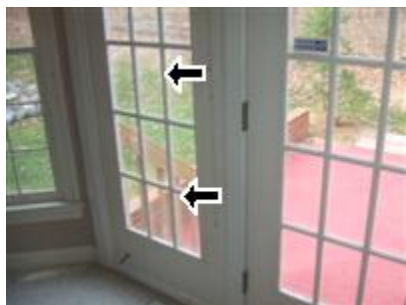
2.3 Picture 1

Stationary door cloudy, and needs replacing. Not operating as intended This can cause some heat loss in winter and loss of cool air in summer if not corrected. Repair/replace using a qualified contractor at rear living room entry door.( Picture 1 )

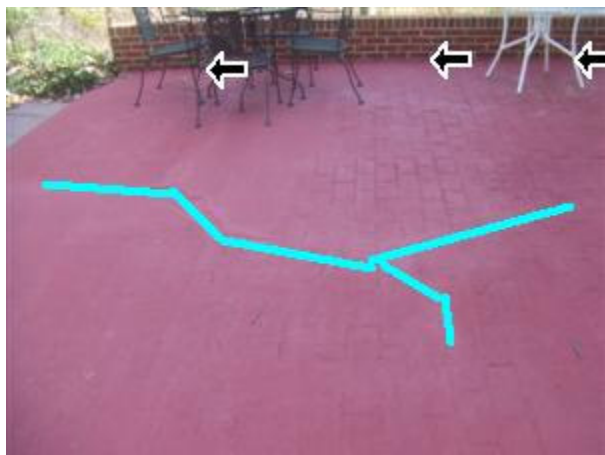
3.6 Picture 1

All patio surfaces should be constructed and maintained so that they slope away from the foundation and water runs off freely. This patio slopes toward house and may cause water penetration. Warrants further investigation by a qualified contractor at rear. Note settlement and signs of dropping of patio around edges

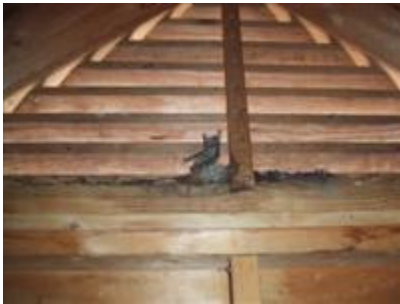
5.4 Picture 1

Bat or bats seen , Bat droppings in attic. It appears they're entering at left rear attic gables. Sometimes pests can cause damage to home or components. Recommend Contact a pest control company for removal or for further prevention of future entry.

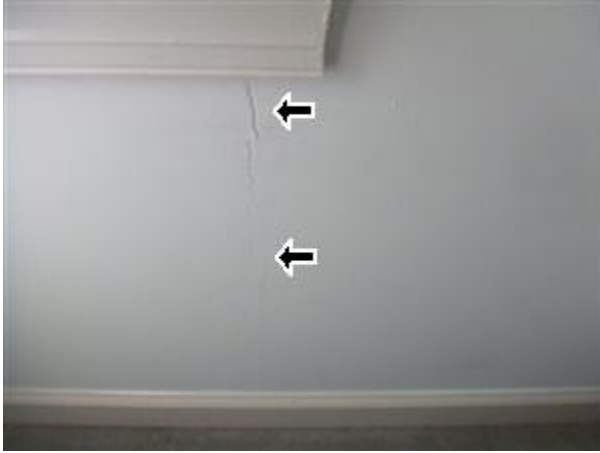
6.3 Picture 1

1. Sheetrock on wall has vertical crack at below second floor left front bedroom window. Further movement could occur. Conditions warrant further investigation by a **qualified/licensed structural engineer** and repair as directed. See EXTERIOR notes for brick siding.( Picture 1 )

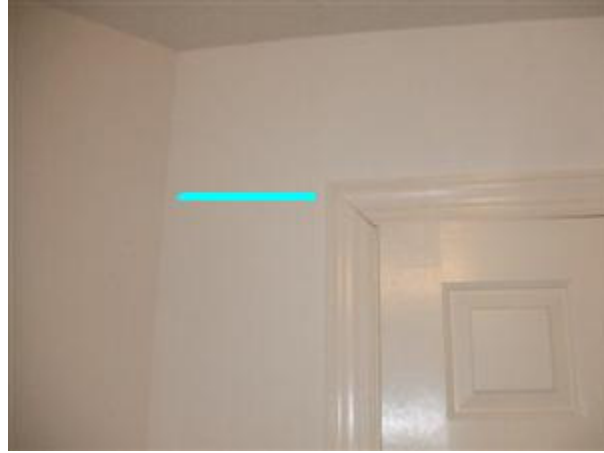
6.3 Picture 2

2. Sheetrock on wall has horizontal crack at second floor left rear bedroom above bedroom door. Further movement could occur. prior repairs noted. Conditions warrant further investigation by a **qualified/licensed structural engineer** and repair as directed.

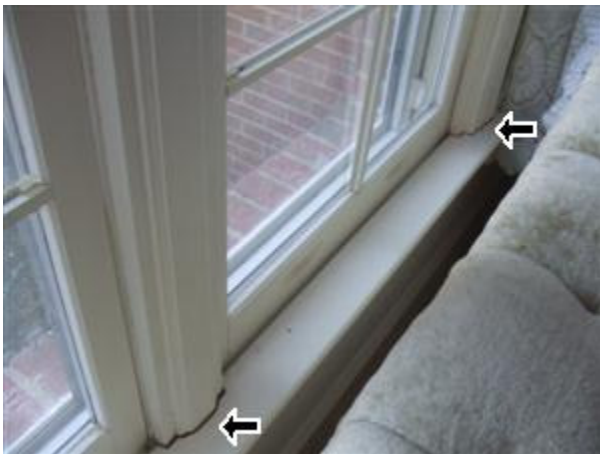
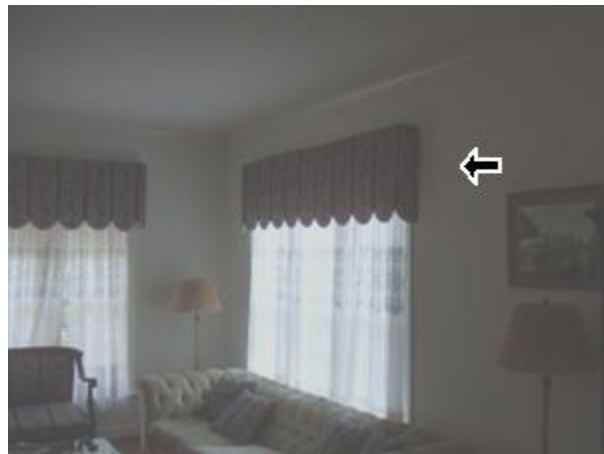
4. Further wall movement found at front dining room window as window sill at interior has separation and at top of window there is horizontal cracking noted that is adjacent to step cracking at exterior brick siding materials. Warrants further review by a licensed structural engineer.( Picture 3 ) ( Picture 4 )

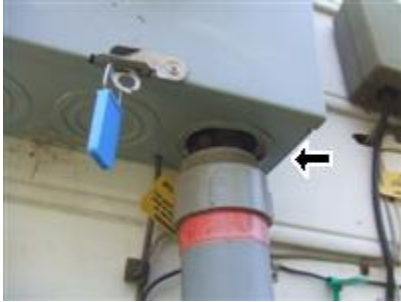
7.0 Picture 1

Main feeder has separated from bottom of meter panel. Should be secured by a licensed electrician or appropriate power company personnel as it may cause undue stress on power supply lines.

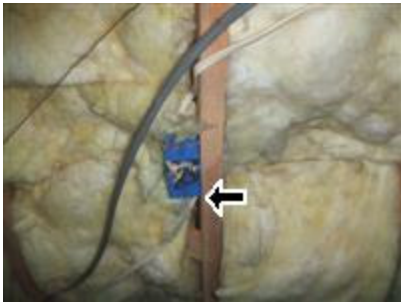
7.4 Picture 1

1. Light fixture did not work (may or may not have bulbs installed). Replace/install bulb(s) and check operation prior to closing at Several exterior fixtures.
2. Wall switch purpose is unknown (could not identify fixture). This is for your information. Ask owner about all switch operations and confirm operation prior to closing at main level left side near french doors.
3. open junction box in crawlspace under left rear living room. Install box cover safety purposes.

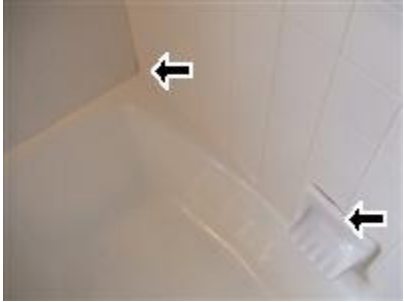
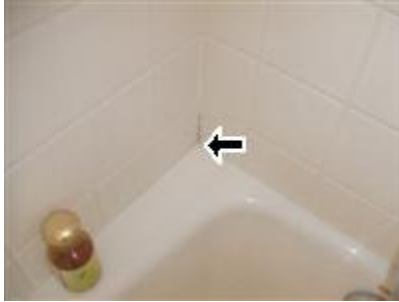
Grouting gaps at various locations in tile enclosure; recommend repair all joints to prevent water penetration at main level full bath soap dish and corners. Conditions behind the materials is indeterminate.

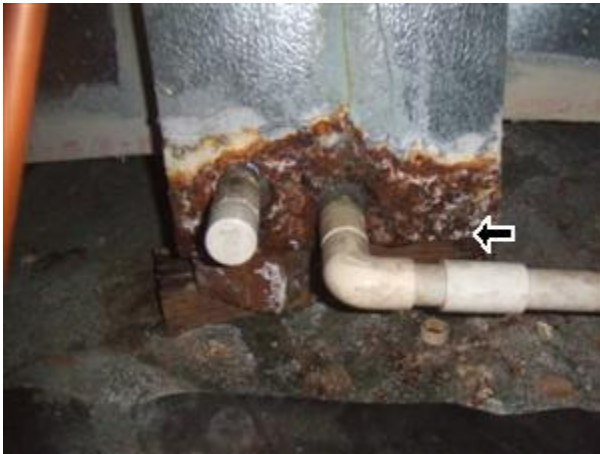
9.0.A Picture 1

System supply was in normal (typical) operating ranges. Functional at time of inspection and rated "fair" for age. Due to advanced age of system and bottom of plenum rusted thru at crawlspace, HVAC contractor should review system prior to closing.

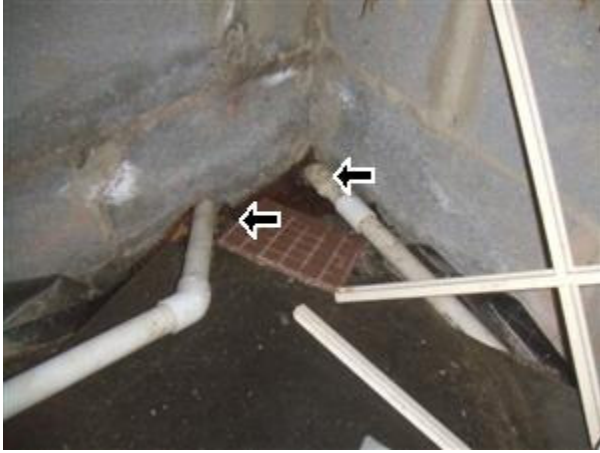
9.3.A Picture 1

Condensate drain lines for both floors were routed to right rear corner of crawlspace (near water heater in garage) and were not draining to exterior as there was standing water in this location. Needs to be corrected to drain to exterior by a qualified contractor or HVAC contractor.

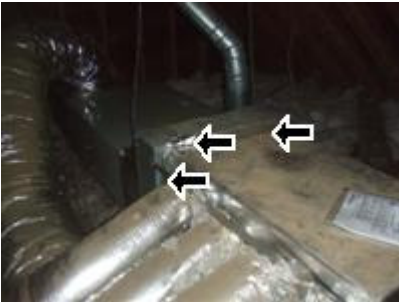
9.2.B Picture 1

Air leaks around plenum at attic unit. Requires review as this can increase cost of operation.

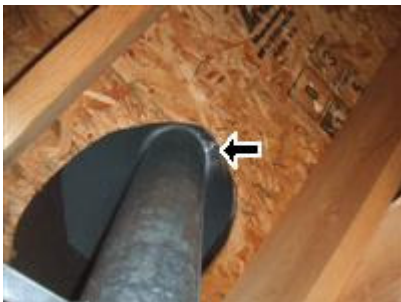
10.4.B Picture 1

Vent pipe for natural gas fired furnace gapped at boot where it exits roof. This is a small repair. Will allow water penetration. Sealing of joint(s) with appropriate materials should be performed by a qualified contractor

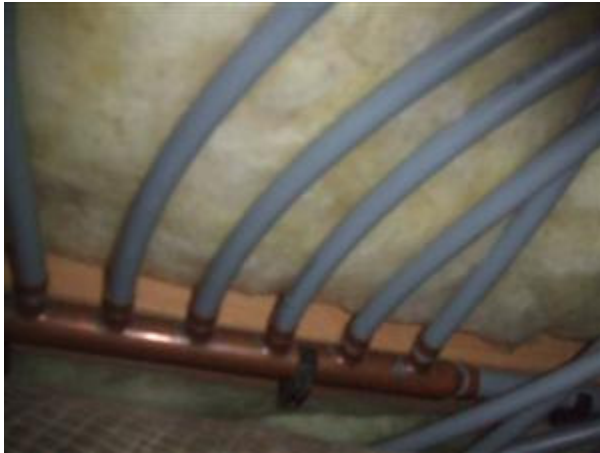
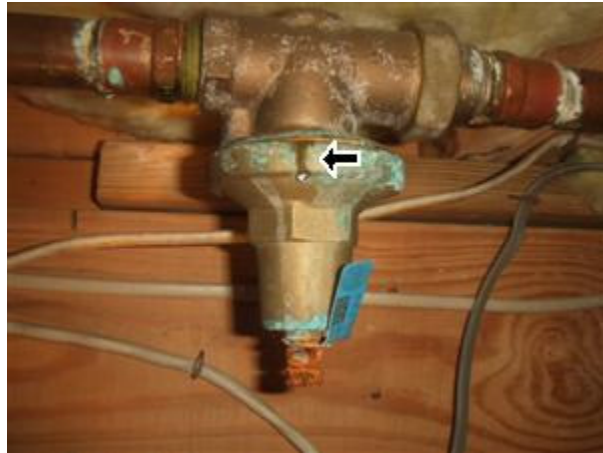
1. Polybutylene type piping in subject house is used for distribution piping. This piping was involved in a class action lawsuit due to issues with materials developing leaks and inherent deficiencies. Monitor condition of floors, walls, ceilings. Visit [www.pbpipe.com](http://www.pbpipe.com) or call 1-800-392-7591 for the Consumer Plumbing Recovery Center for further information on available programs. It is in your best interest to cut off the main water supply if house will be unoccupied for any length of time. When restoring main water service turn valve very slowly to reduce vibration of plumbing system.
2. Water leak found at second pressure regulator near foyer area of crawlspace. Currently leaking at time of inspection. Requires repair by a licensed plumber.

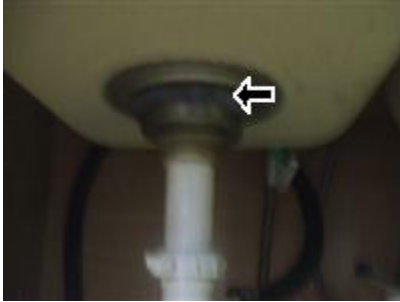
13.2 Picture 1

Plumbing waste line leaking. Not operating as intended. Not operating as intended Repairs are needed to stop leaking water from damaging the cabinet bottom or to eliminate moisture that may contribute to mold growth Repair/replace by a licensed plumber at main level left side kitchen sink

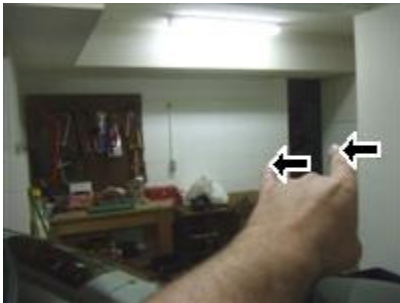
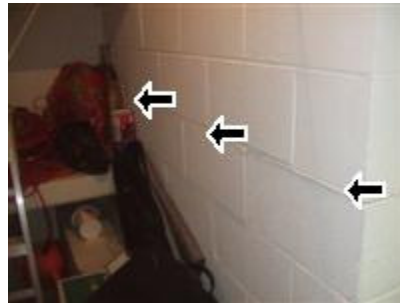
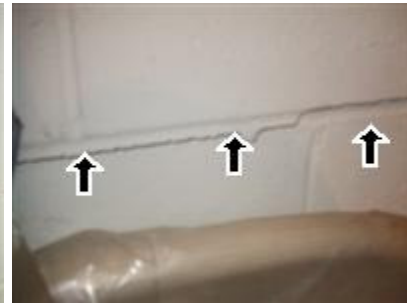
- Cracks in foundation walls that suggest pressure (horizontal cracks) at bottom of basement steps in storage area and in closet under stairwell to garage. Some Cracks are covered by storage also. Warrants further review by a licensed structural engineer. Other cracks found in front foundation walls at area below main level front bedroom window and under front porch foundation (as seen in crawlspace).

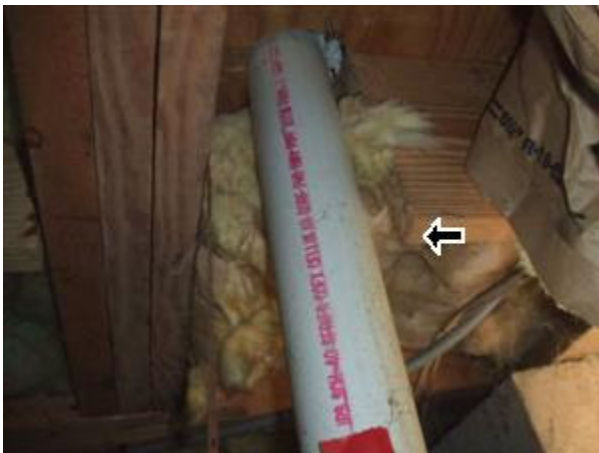
14.3 Picture 1

Floor joist had been excessively notched at left side laundry/bathroom (waste line marked with red duct tape). Requires review and repair by a licensed general contractor to future movement.
