LaBrake Services, Inc. dba HouseMaster
Inspector: Dan LaBrake OK License # 121

HouseMaster Inspections
9811 S. 226 E. Ave
Broken Arrow, OK 74014
Bus: (918) 455-4406 Fax: (918) 455-1792
Inspection Date: 4/6/2011

General Home Inspection

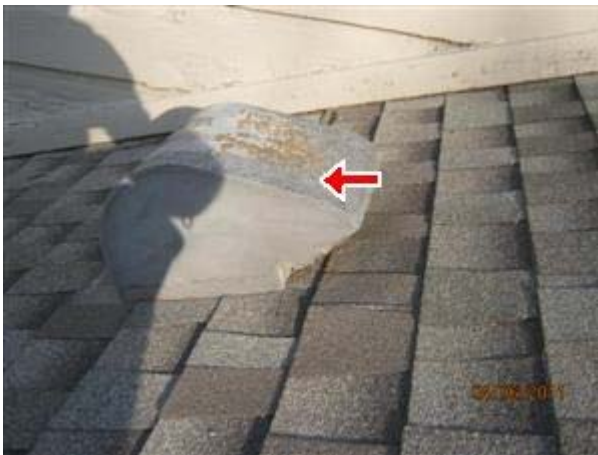
2.5 VENTILATION COVERS Picture 1

•			2.5 VENTILATION COVERS The hood for the bathroom fan on the right front slope discharges upwards to the roofline instead of down the roofline. It is possible during heavy snow events that moisture could enter the vent. Recommend having a roofer rotate the hood to point down the roof. The screens on the gable vents off the master bedroom attic are coming loose which allow birds to enter the area. Recommend securing.

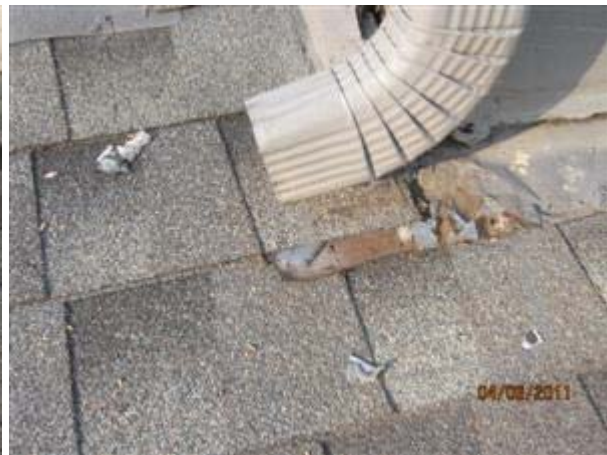
2.7 GUTTERS / DOWNSPOUTS / ROOF DRAINS Picture 1

•				2.6 PLUMBING STACKS
	•			2.7 GUTTERS / DOWNSPOUTS / ROOF DRAINS A downspout arrangement that allows water to discharge onto lower roofs can lead to premature roof wear and/or leakage. The existing arrangement should be corrected by extending downspouts termination points to ground level or a lower gutter to reduce the potential for recurring rainwater drainage problems and damage.

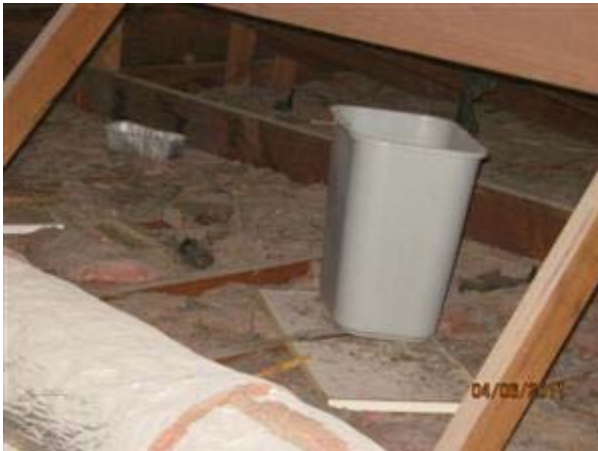
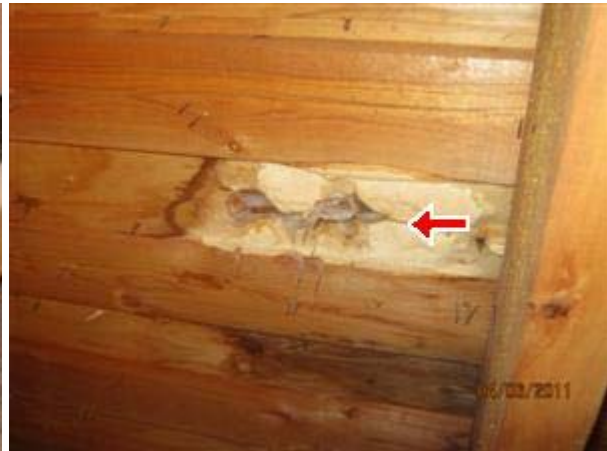
•				2.8 FASCIA / SOFFITS
				2.9 OTHER Trash can noted in the attic area off the master bedroom closet under the front roof slope. Heavy area of silicone noted in the decking area. Most likely this was due to a branch hitting the roof in the past. No current concern.

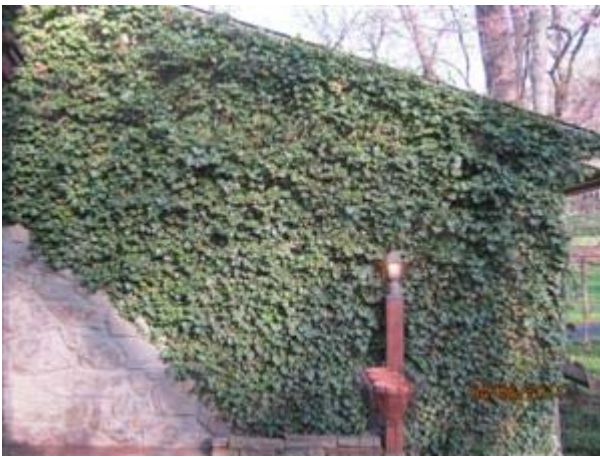
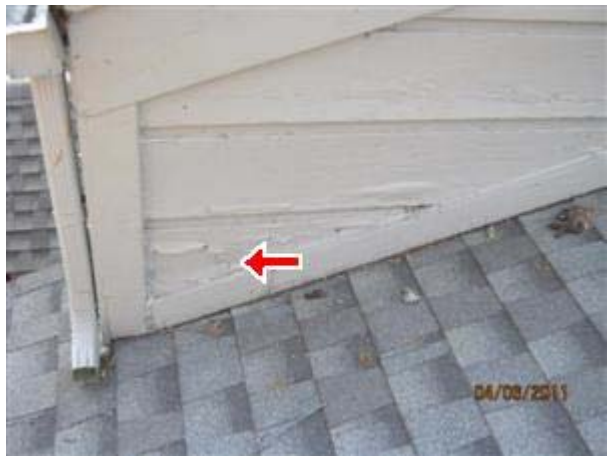
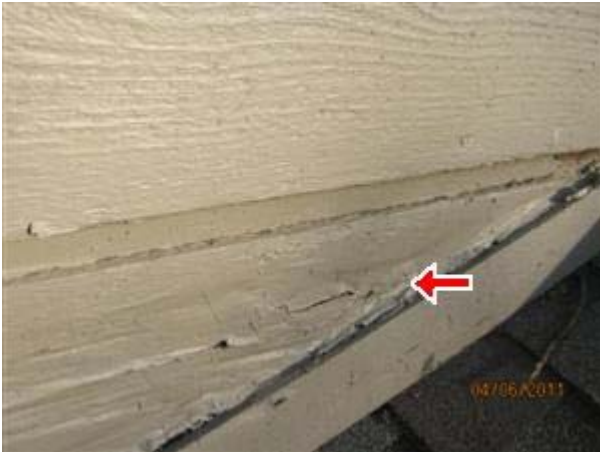
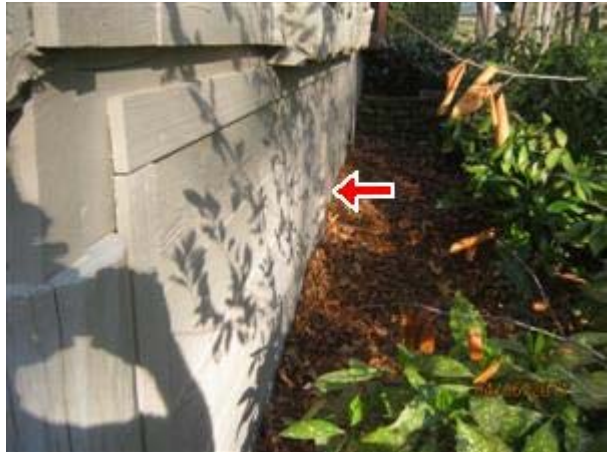
•					3.0 SIDING 1
		•			3.1 SIDING 2 1. Ivy climbing on the walls at the front door and the right rear area. This is a very detrimental condition for the siding, recommend removing. 2. There is some early signs of decay at the siding joints along the roof lines on both sides of the front dormer area and at both sides of the house where the roof line stops along the siding wall. Affected materials should be repaired/replaced. 3. Conducive conditions exist where the wood skirting along the NE area of the house is in contact with the soil. Repair/replace as desired.

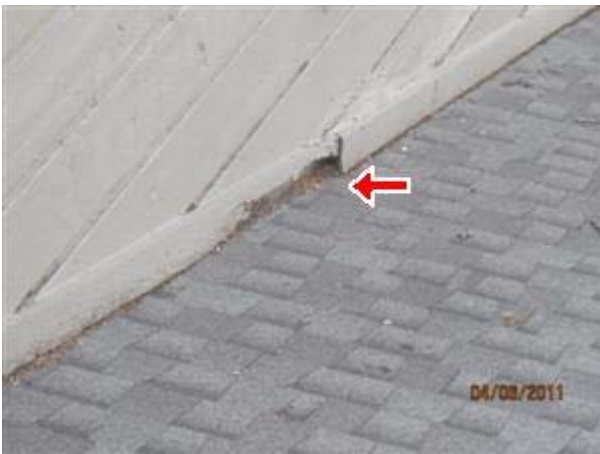
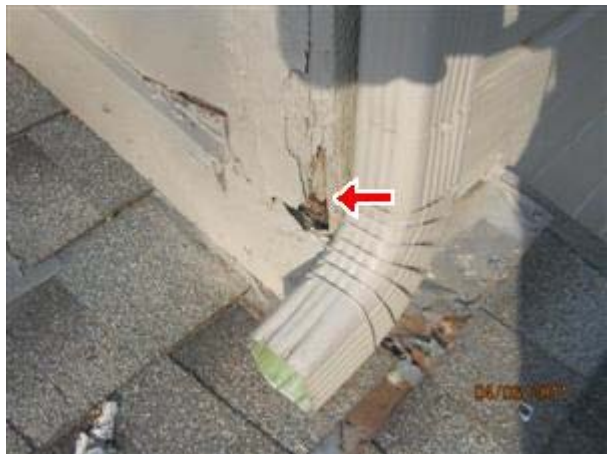
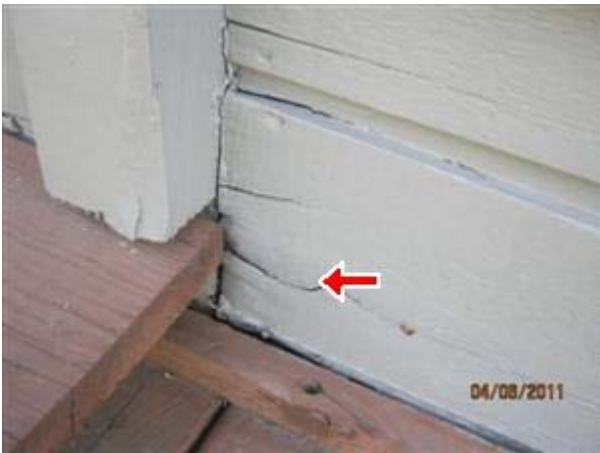
•			3.2 TRIM Wood decay found at the following areas, have repaired or replaced: 1. Along the trim board on the roofline on the rear slope on the right side 2. Bottom of the rear living room door along the deck boards near the door. 3. Vertical trim board at the left front gutter on the lower level roof area

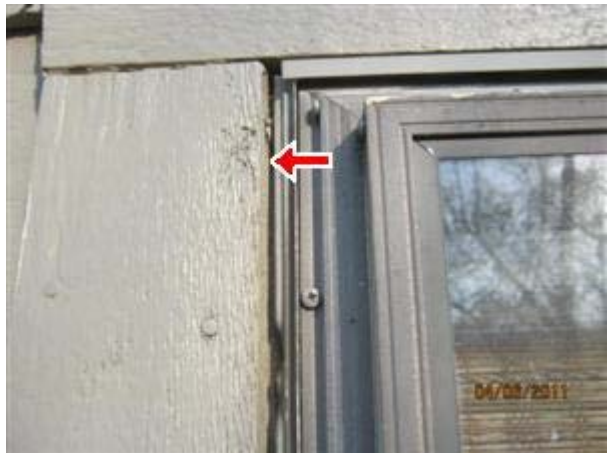
3.3 WINDOWS Picture 1

•					3.3 WINDOWS Note: 3 of the 4 windows in the rear basement room have not been opened in some time, they are stuck in the closed position. Recommend making them operational. Recommend caulking the joints around the windows to prevent potential moisture entry.

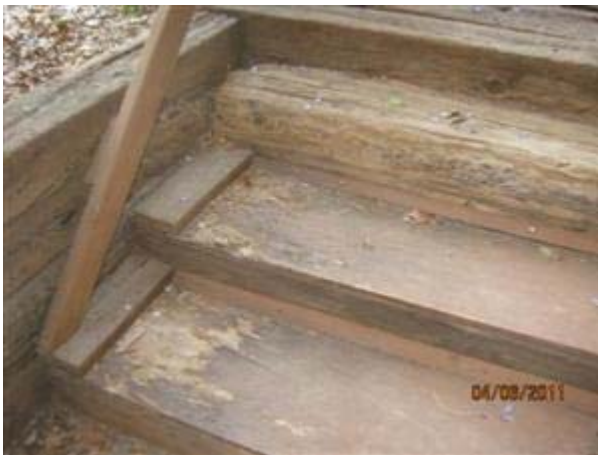
3.5 STAIRS / STOOPS Picture 1

•			3.5 STAIRS / STOOPS Wood decay on the timbers and plywood on the steps to the right rear basement door. Replace as necessary.
		•			3.6 PORCH(ES) / DECK(S) The tree on the right side deck area is pushing the rim joist out on the West side causing the floor joists to pull out of the joist hangers. The opening around the tree needs to be enlarged and the connections for the floor joists secured.
