Mrs. Home Buyer

123 Your New Home Dr.

ClearView Inspection Service DBA: HouseMaster

Inspection Date: 5/26/2011

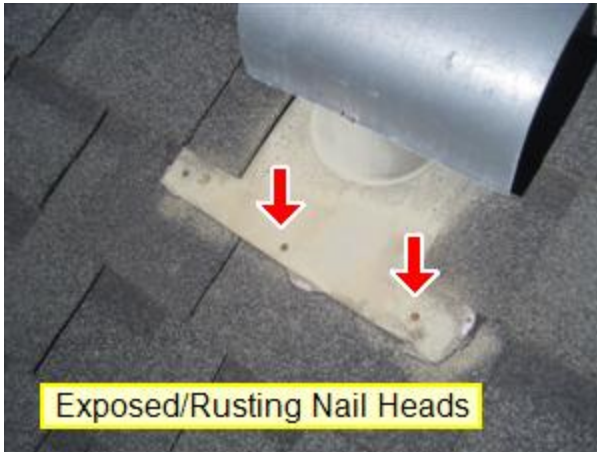
1.2 EXPOSED FLASHING Picture 1

•					1.1	<b>CHIMNEYS / VENTS</b> Inspection of chimney is limited to visible areas only. See interior section for comments related to firebox.
	•				1.2	<b>EXPOSED FLASHING</b> Exposed and rusting nails noted. Seal as required to prevent water penetration. (Picture 1)

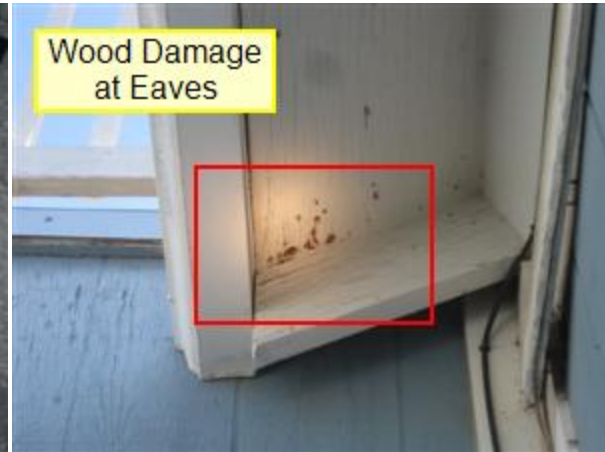
1.7 FASCIA / SOFFITS Picture 1

•			1.7	<b>FASCIA / SOFFITS</b> Inspection is limited to readily accessible and visible areas only. Monitor, seal, repair on an annual basis as part of routine maintenance.  Wood damage noted at eaves/fascia/ soffit areas. Consult pest control company for further evaluation and repairs to damaged wood. (Picture 1)  Paint is peeling and/or loose at various locations. Due to the age of the home (1978 and older), the paint may contain lead. Suggest repairs and repainting to preserve wood. Use care when working with old materials, especially with paint. Have tested if desired and/or removing.

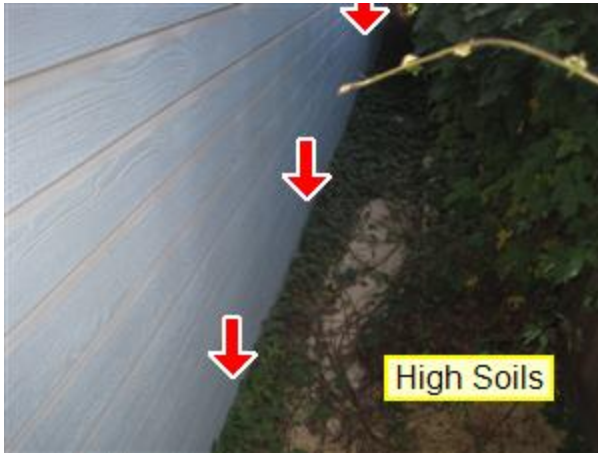
2.0 SIDING Picture 1

S	F	P	NA	NI	
		•			<p><b>2.0 SIDING</b></p> <p>Wood siding has damage, rot and gaps. Anticipate repairs and seal all gaps to prevent water damage. See pest control report. (Picture 2)</p> <p>Paint is loose and/or peeling at various locations. Paint may contain lead, if built prior to 1979. However, no testing was performed. Prior repairs and painting noted at siding.</p> <p>Soil level is too high at various locations of structure. Condition is conducive to wood destroying organisms and moisture damage and/or penetration into structure. Suggest lowering soil and maintaining proper drainage away from structure. Siding should be a minimum of 4 inches away from soil and 2 inches away from concrete is recommended. (Picture 1)</p>

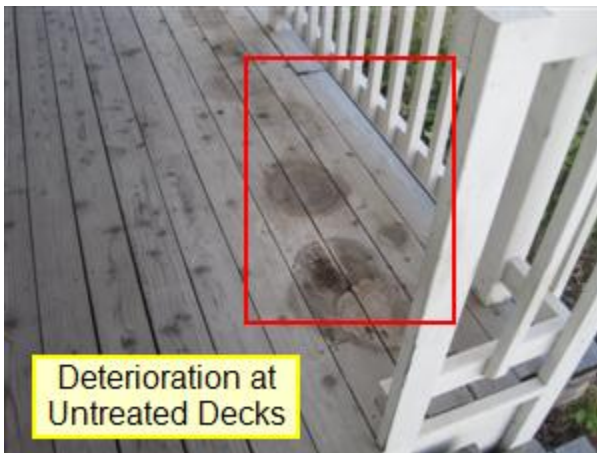
2.4 PORCH(ES) / DECK(S) Picture 1

•			<p><b>2.3 STAIRS / STOOPS</b></p> <p>Rotted stairs with cracked and loose treads noted. Anticipate repair/replacement.</p>
		•			<p><b>2.4 PORCH(ES) / DECK(S)</b></p> <p>Weathering/ Deterioration noted at untreated wood decks. Anticipate repair/replacement. Suggest routine maintenance/ paint/ repair/ replacement of components for enhanced life span of structure. (Picture 1)</p>

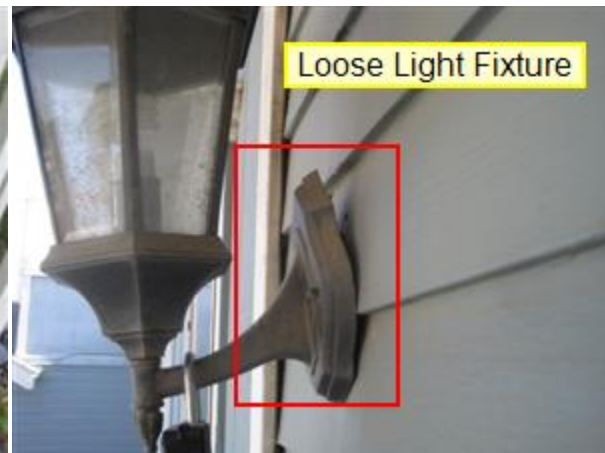
2.5 ELECTRIC / GFCI Picture 1

•				<p><b>2.5 ELECTRIC / GFCI</b></p> <p>Loose exterior light fixtures noted. Secure for proper and safe installation and to prevent pest intrusion. (Picture 1)</p>

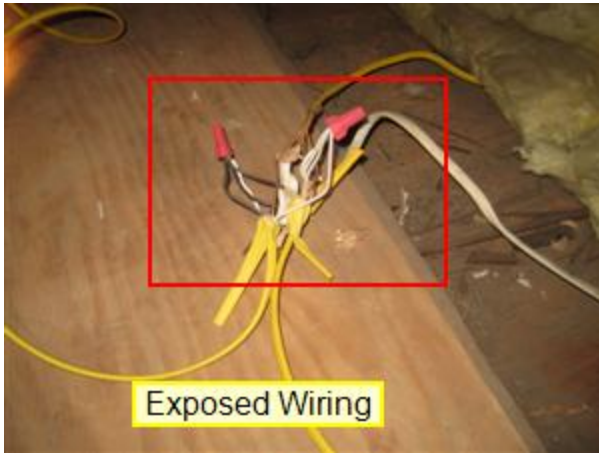
5.0 ROOF FRAMING Picture 1

S	F	P	NA	NI	
•					<b>5.0 ROOF FRAMING</b> No structural conditions to report in attic. See pest control report for conditions related to wood framing members.  Exposed wiring noted in attic. Add cover plates at open junction boxes and/or properly terminate wiring for proper and safe installation. See main electric section for possible additional comments and supplemental information. (Picture 1)

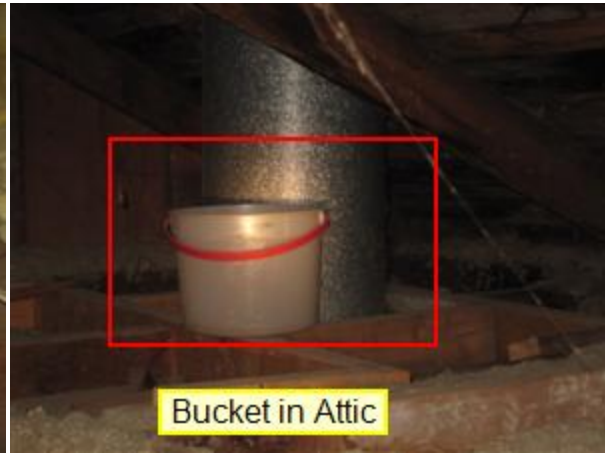
5.1 ROOF DECK / SHEATHING Picture 1

•				<b>5.1 ROOF DECK / SHEATHING</b> Plastic bucket noted in attic above water damaged ceiling at living room wood burning stove. Consult seller on history of water leaks and repairs. (Picture 1)

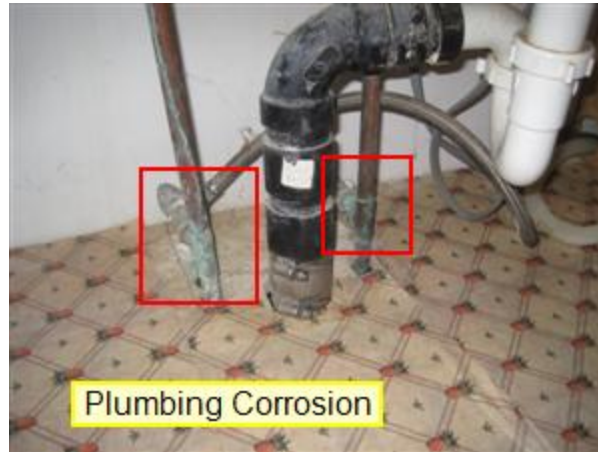
7.0 PLUMBING / SINK Picture 1

•					7.0	<b>PLUMBING / SINK</b> Corrosion on plumbing under kitchen sink noted. Monitor and repair/ replace components as needed to prevent leaks. (Picture 1)

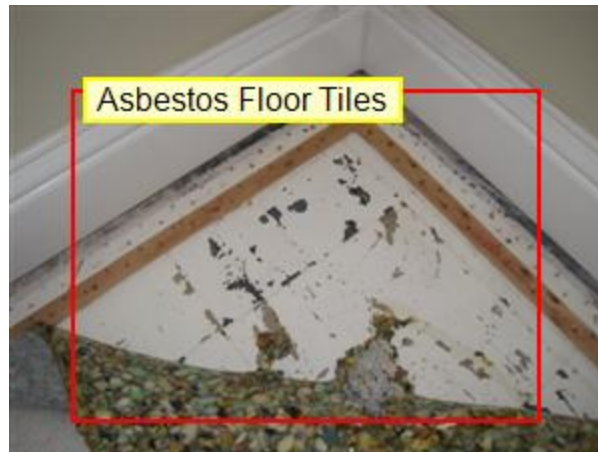
8.2 FLOORS Picture 1

•					8.0	<b>WALLS</b>
	•				8.1	<b>CEILINGS</b> Plastic bucket noted in attic above water damaged ceiling at living room wood burning stove. Consult seller on history of water leaks and repairs.
		•			8.2	<b>FLOORS</b> Unlevel floors noted. Consult a foundation contractor for further evaluation and repairs if level floors are desired. See sub area and grading comments.  Floor tiles in living room beneath carpet contain asbestos (9" linoleum). Consult flooring contractor for testing prior to disturbing.
•					8.3	<b>ROOM DOORS</b>
•					8.4	<b>PATIO / DECK DOORS(S)</b>
		•			8.5	<b>DETECTOR TEST</b> No smoke detectors in hallway and front bedrooms. Install in hallway as required for safety and bedrooms for upgrades. Suggest testing on a regular basis for safety.

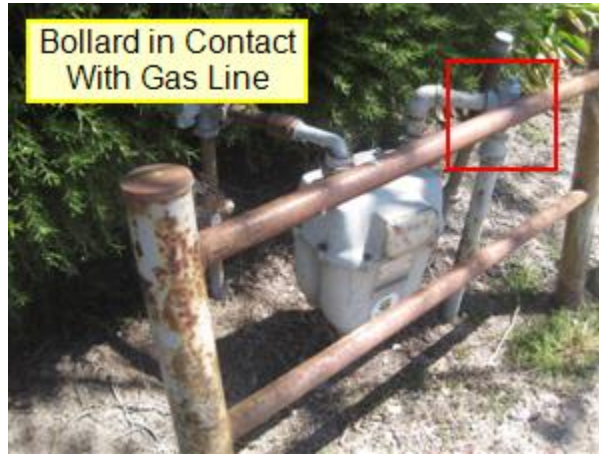
12.6 GAS PIPING Picture 1

Bollard at gas meter has been struck by a car and in contact with gas lines. Repair or replace bollard for proper protection of gas lines and meter. (Picture 1)

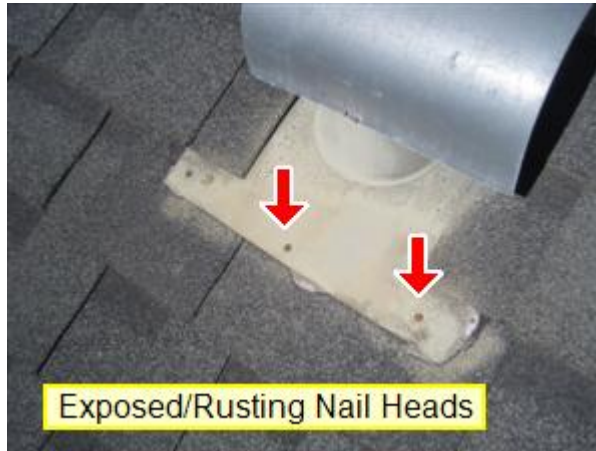
1.2 Picture 1

Exposed and rusting nails noted. Seal as required to prevent water penetration. (Picture 1)

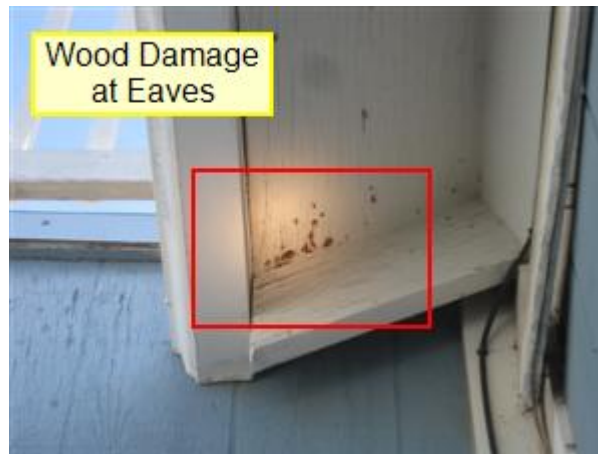
1.7 Picture 1

Wood damage noted at eaves/fascia/ soffit areas. Consult pest control company for further evaluation and repairs to damaged wood. (Picture 1)

Paint is peeling and/or loose at various locations. Due to the age of the home (1978 and older), the paint may contain lead. Suggest repairs and repainting to preserve wood. Use care when working with old materials, especially with paint. Have tested if desired and/or removing.

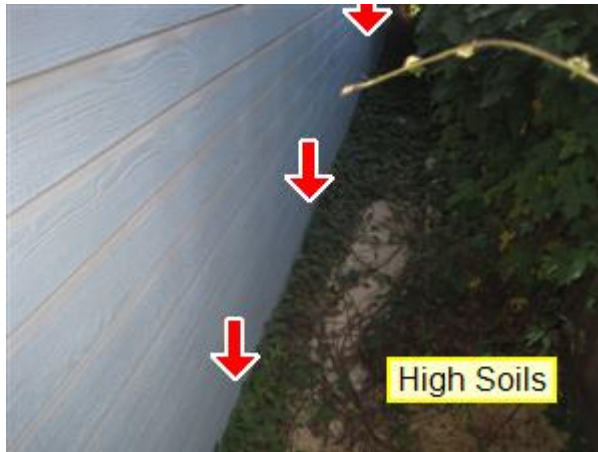
2.0 Picture 1

Soil level is too high at various locations of structure. Condition is conducive to wood destroying organisms and moisture damage and/or penetration into structure. Suggest lowering soil and maintaining proper drainage away from structure. Siding should be a minimum of 4 inches away from soil and 2 inches away from concrete is recommended. (Picture 1)

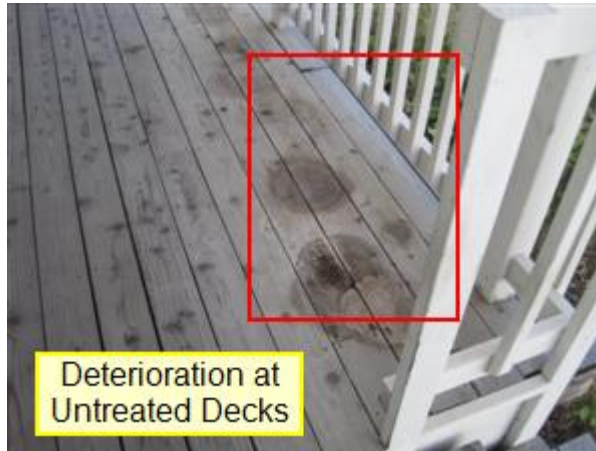
2.4 Picture 1

Weathering/ Deterioration noted at untreated wood decks. Anticipate repair/replacement. Suggest routine maintenance/ paint/ repair/ replacement of components for enhanced life span of structure. (Picture 1)

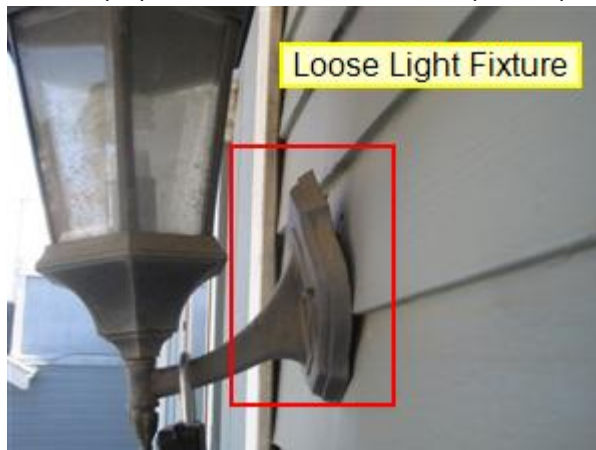
2.5 Picture 1

Loose exterior light fixtures noted. Secure for proper and safe installation and to prevent pest intrusion. (Picture 1)

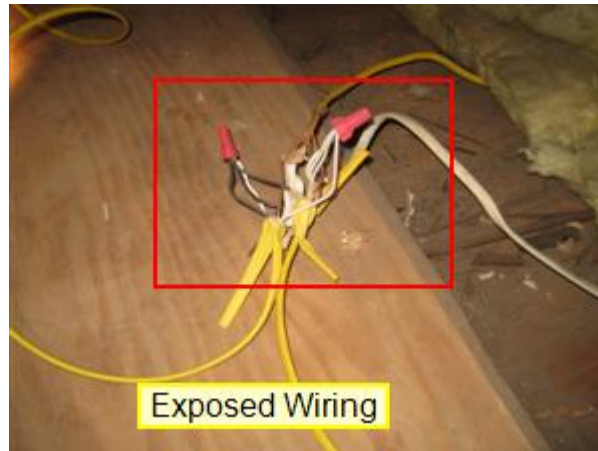
5.0 Picture 1

Exposed wiring noted in attic. Add cover plates at open junction boxes and/or properly terminate wiring for proper and safe installation. See main electric section for possible additional comments and supplemental information. (Picture 1)

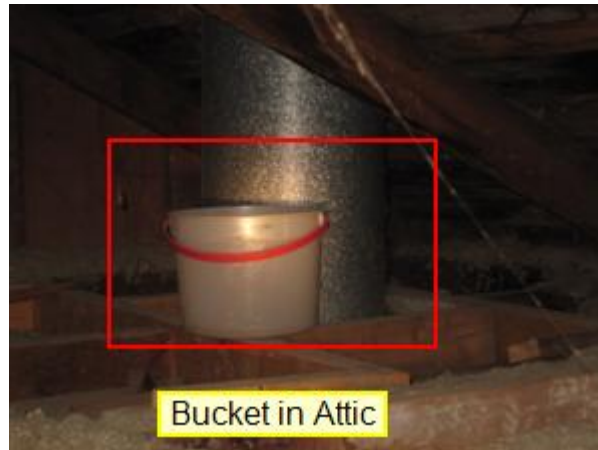
5.1 Picture 1

Plastic bucket noted in attic above water damaged ceiling at living room wood burning stove. Consult seller on history of water leaks and repairs. (Picture 1)

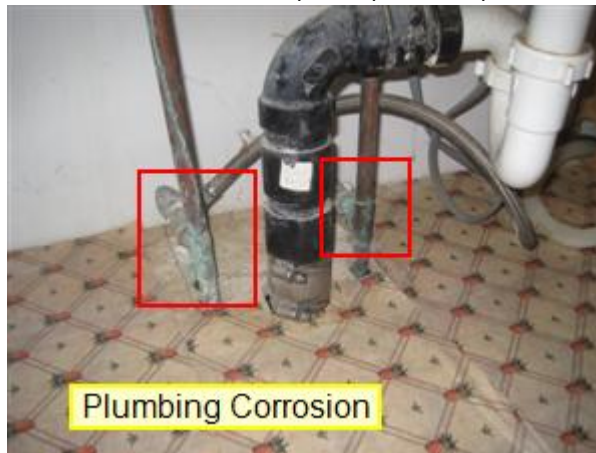
7.0 Picture 1

Corrosion on plumbing under kitchen sink noted. Monitor and repair/ replace components as needed to prevent leaks. (Picture 1)

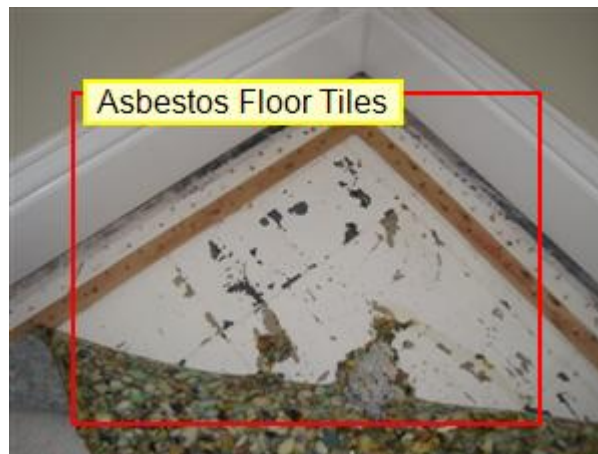
8.2 Picture 1

Unlevel floors noted. Consult a foundation contractor for further evaluation and repairs if level floors are desired. See sub area and grading comments.

Floor tiles in living room beneath carpet contain asbestos (9" linoleum). Consult flooring contractor for testing prior to disturbing.

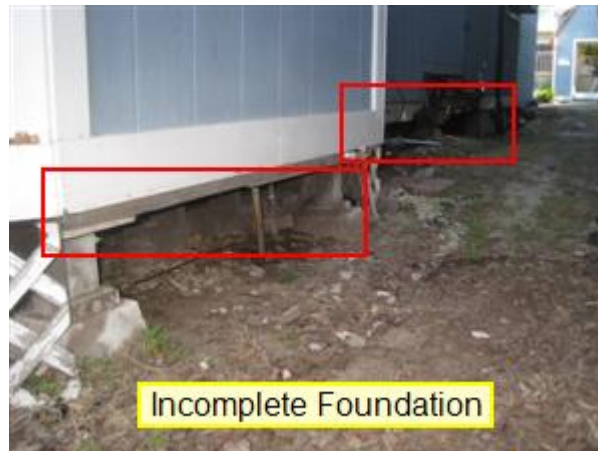
9.0 Picture 1

Wood to soil contact noted at wood framed floor of master bedroom addition. Suspected unpermitted addition. Consult county building department and a foundation contractor for evaluation and repairs as required.

Consult a foundation contractor for remediation cost estimates prior to the close of escrow.
