1600 Pennsylvania Ave  
Prairieville LA 70769

Pro2Call Property Evaluations LLC dba HouseMaster

Inspection Date: 10/10/2008

**INSPECTION INFORMATION**

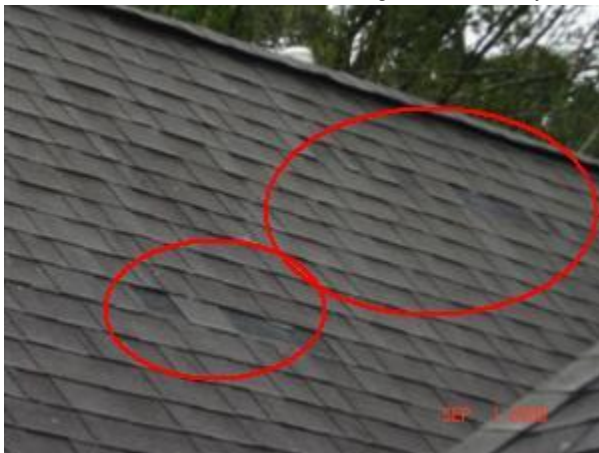
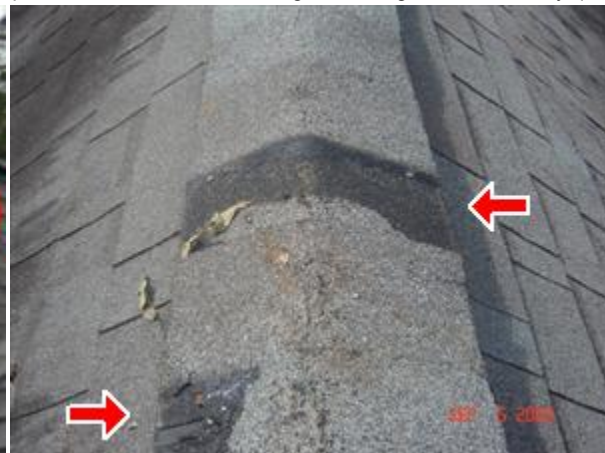
•				1.0 <b>ROOF COVERING</b>  The roof conditions observed might be indicative of roof wear, hail or storm damage, manufacturing defects, and/or other conditions. Home owner advises they are awaiting storm damage insurance claim and roof will be replaced before closing. Follow up and verify reroofing was complete before closing. Obtain copies of receipts and warranties.

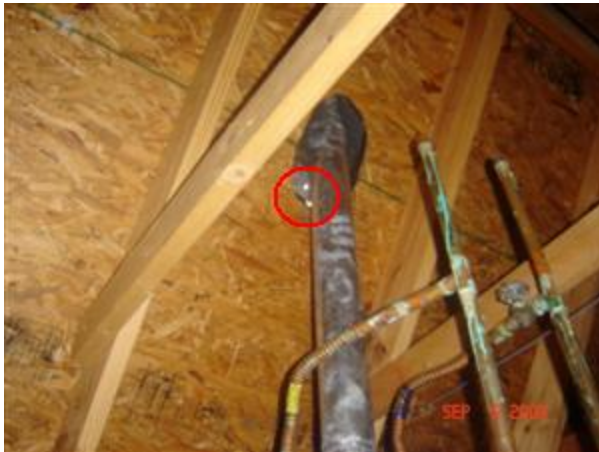
1.1 EXPOSED FLASHING Picture 1

•				1.1 <b>EXPOSED FLASHING</b> Damaged flashing observed in several areas. Verify flashing deficiencies are corrected with roof replacement as indicated in the Roof Covering comments.

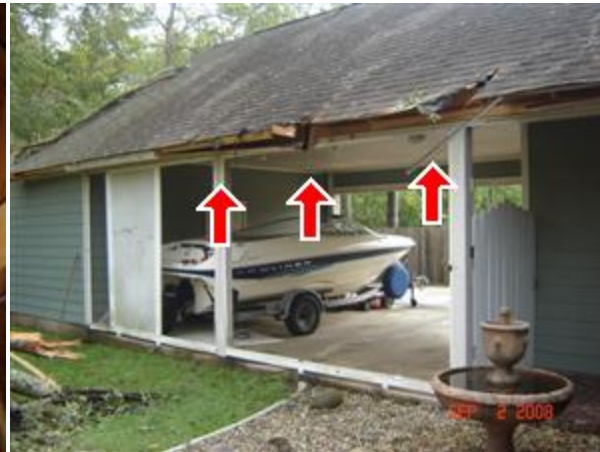
1.6 FASCIA / SOFFITS Picture 1

•				1.5 <b>DOWNSPOUTS / ROOF DRAINS</b>
									1.6 <b>FASCIA / SOFFITS</b> Soft/fascia damaged sheathing noted at along edge of roof; home owner indicates this will be replaced during reroofing. (see Roof Covering comments) Verify work completion before closing.

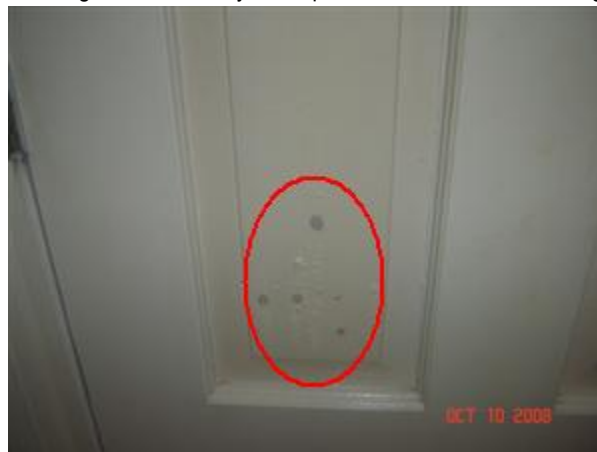
2.2 ENTRY DOORS Picture 1

•					2.0 SIDING
•					2.1 WINDOWS
	•				2.2 ENTRY DOORS Main entry door has paint bubbles on the interior. This may be cosmetic but also shows signs of possible water penetration. Sand and repaint to avoid wood rot or insect infestation.
•					2.3 PORCH(ES)
•					2.4 ELECTRIC / GFCI
•					2.5 EXTERIOR FAUCET(S)

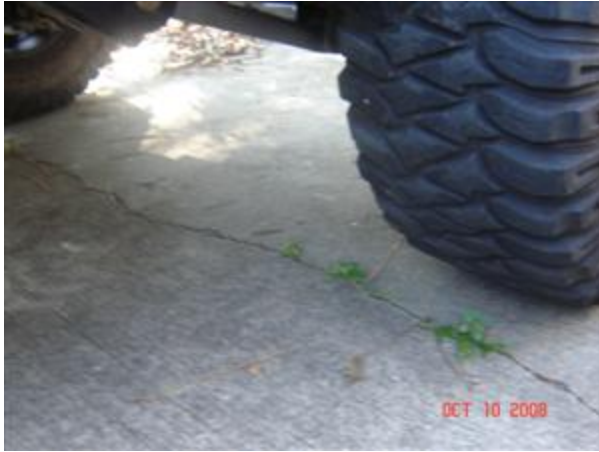
3.2 DRIVEWAY Picture 1

•					3.0	PATIO(S)
•					3.1	WALKWAYS
	•				3.2	DRIVEWAY Cracking noted; recommend seal cracks.
	•				3.3	GROUND SLOPE AT FOUNDATION  A negative grade slope toward the foundation allows water runoff and ponding. This condition can causes structural and/or water infiltration problems. Excessive soil/water pressures can actually cause lateral movement of the foundation, a potentially serious concern. Deficiencies must be corrected and suitable drainage conditions must be maintained in order to prevent problems. Most notable deficiency occurs in the small alcove at the front of the house. Gutters are also needed here. (see Gutter comments in Roofing section)
•					3.4	SITE GRADING

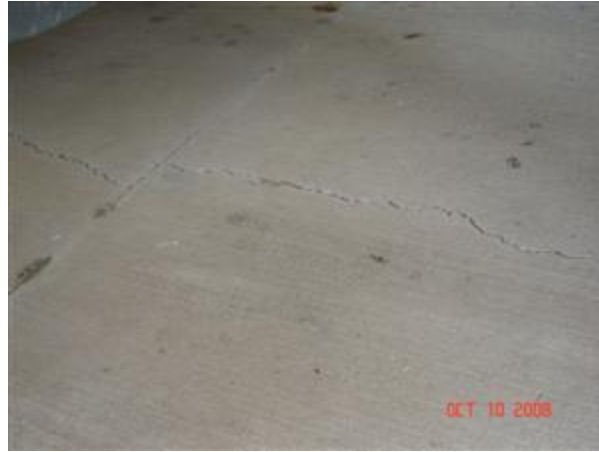
4.2 FLOOR SLAB Picture 1

•			4.0	<b>ROOFING</b> See comments in Roofing section
			•		4.1	<b>EXPOSED FRAMING</b>
	•				4.2	<b>FLOOR SLAB</b> Cracking and settlement of floor slab noted; recommend seal cracks.
•					4.3	<b>ATTIC VENTILATION</b>
•					4.4	<b>WALLS / CEILINGS</b>
•					4.5	<b>SIDING</b>
•					4.6	<b>VEHICLE DOOR(S)</b>
•					4.7	<b>DOOR OPERATOR(S)</b>
	•				4.8	<b>ELECTRIC / GFCI</b> The outlet for the garage door opener is missing an outlet cover. Replace.

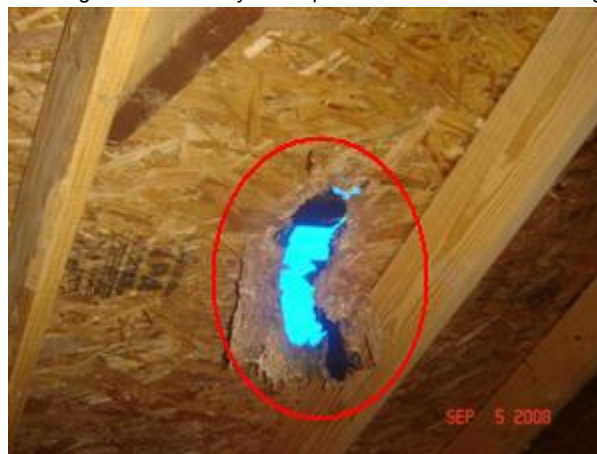
5.1 ROOF DECK / SHEATHING Picture 1

•					5.0	<b>ROOF FRAMING</b>
		•			5.1	<b>ROOF DECK / SHEATHING</b> Home owner indicates storm damaged sheathing will be replaced before closing. (see Roofing Comments) Verify before closing.
•					5.2	<b>VENTILATION PROVISIONS</b>
•					5.3	<b>INSULATION</b>
•					5.4	<b>ATTIC STAIRS</b>

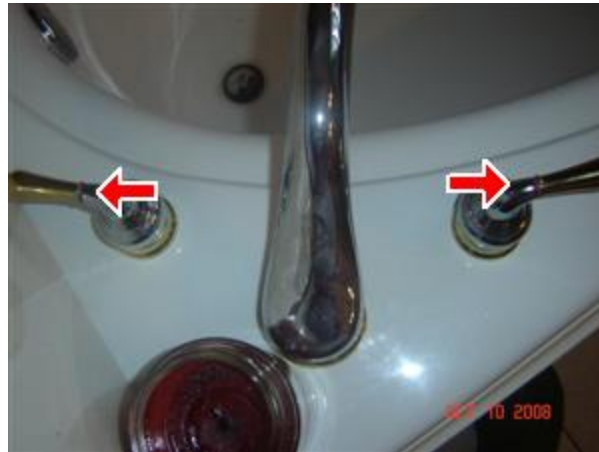
6.8.B JETTED BATH Picture 1

•					6.0.B	SINK(S)
•					6.1.B	TOILET
•					6.2.B	STALL SHOWER
•					6.3.B	SURROUND / ENCLOSURE
•					6.4.B	FLOOR(ING)
•					6.5.B	WALLS / CEILING
•					6.6.B	VENTILATOR
•					6.7.B	ELECTRIC / GFCI
	•				6.8.B	JETTED BATH
<p>A limited check of the bathtub jets indicated there was water flow and aeration. A complete evaluation of the jetted bath system or its effectiveness was not performed. Recommend review of operational and maintenance procedures with the homeowner.</p> <p>Hot and cold facet handles on the tub (blue trim ring/red trim ring) are backwards from the hot and cold water sources. A simple switch of handles is recommended to avoid someone turning the wrong handle.</p>

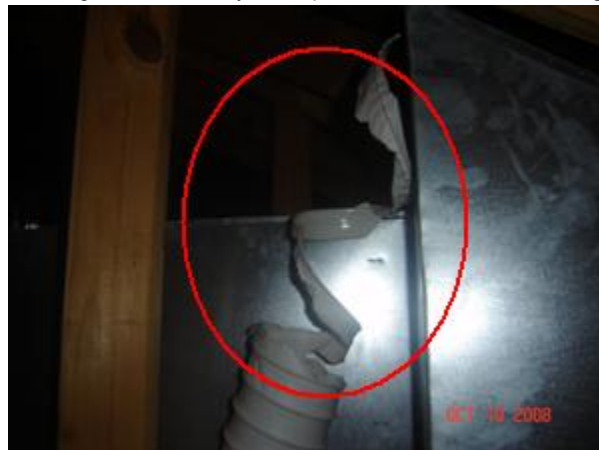
6.4.C VENTILATOR Picture 1

**Ventilator Discharge** - The bathroom exhaust fan should discharge directly to the exterior to prevent excess moisture concerns in the house or attic area. Recommend adding an extension to a suitable discharge point or correcting the current arrangement as conditions warrant.

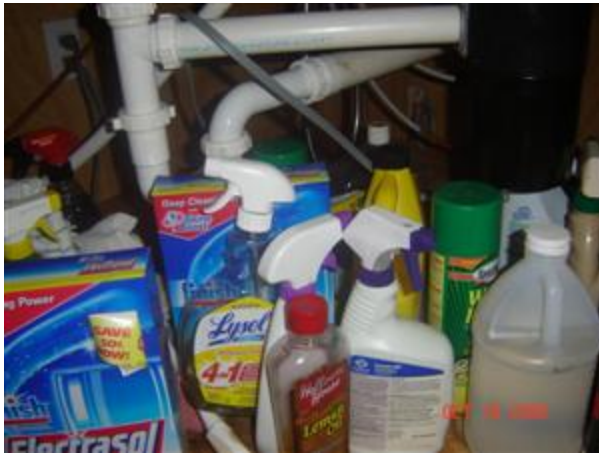
7.0 PLUMBING / SINK Picture 1

The cabinet area is obstructed with excessive storage. There appears to be stains of an old leak. No leak was occurring at time and date of inspection. Inspect after storage items removed and before closing for damage.

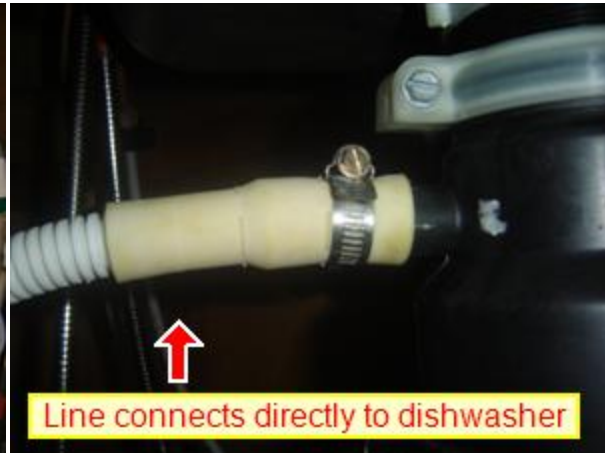
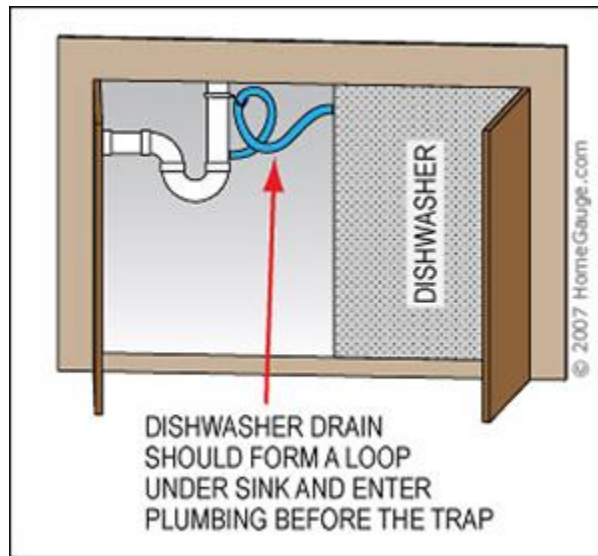
Dish washer discharge line does not use a sink top vent. The dishwasher drain line connects directly to the garbage disposal. When no sink top vent is present, dishwasher drain line should form a loop to prevent waste back flow into the dishwasher. This presents the possibility to contaminate the clean water supply in the home. There may be an installation or drainage issue. Have checked prior to closing.

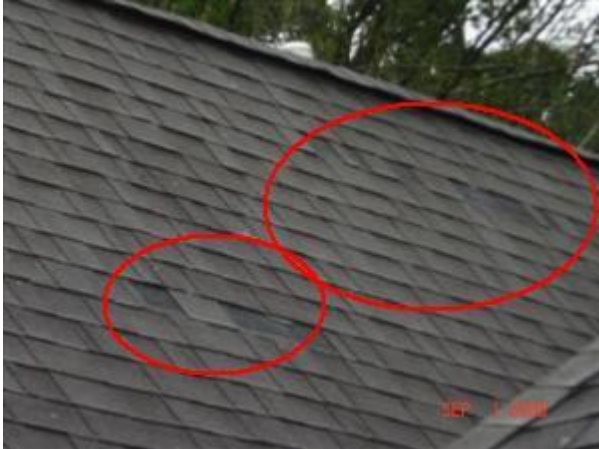
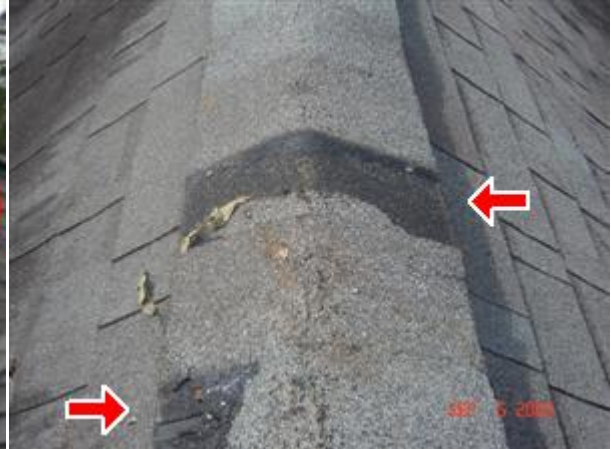
**Poor**

The roof conditions observed might be indicative of roof wear, hail or storm damage, manufacturing defects, and/or other conditions. Home owner advises they are awaiting storm damage insurance claim and roof will be replaced before closing. Follow up and verify reroofing was complete before closing. Obtain copies of receipts and warranties.

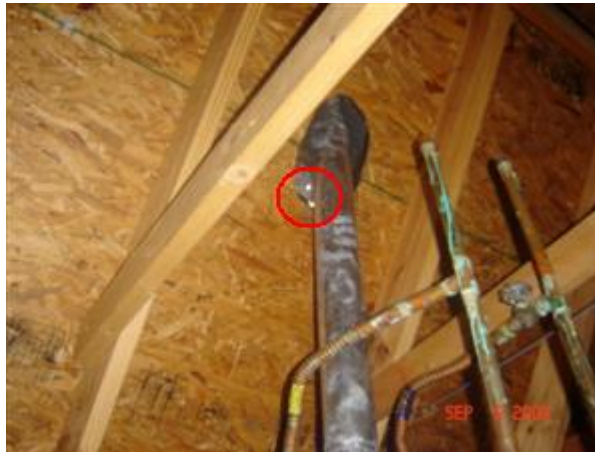
1.1 Picture 1

**Poor**

Damaged flashing observed in several areas. Verify flashing deficiencies are corrected with roof replacement as indicated in the Roof Covering comments.

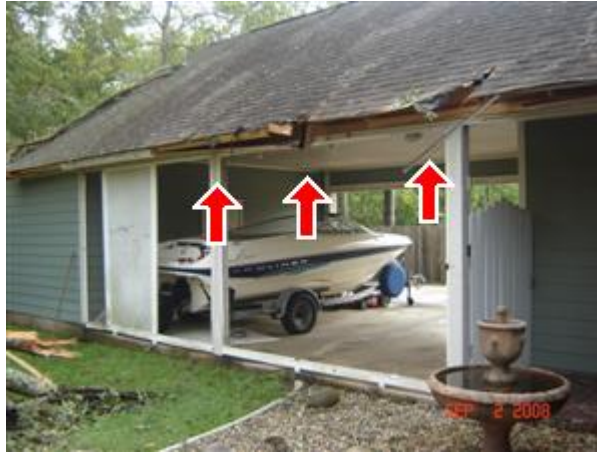
1.6 Picture 1

#### Poor

Soft/fascia damaged sheathing noted at along edge of roof; home owner indicates this will be replaced during reroofing. (see Roof Covering comments) Verify work completion before closing.

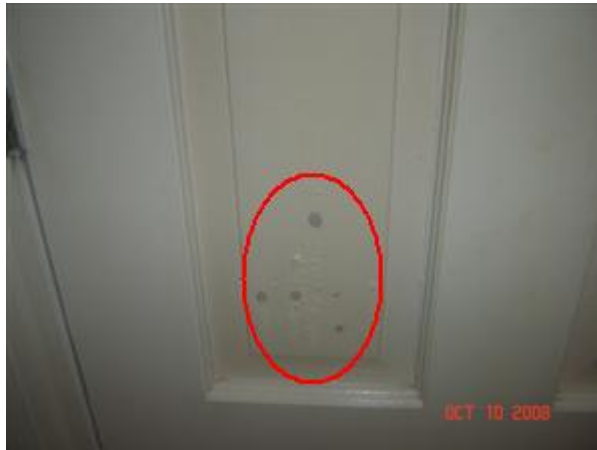
2.2 Picture 1

#### Fair

Main entry door has paint bubbles on the interior. This may be cosmetic but also shows signs of possible water penetration. Sand and repaint to avoid wood rot or insect infestation.

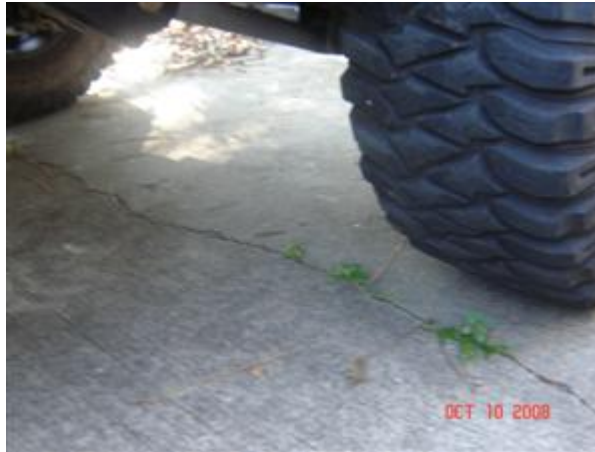
3.2 Picture 1

Fair

Cracking noted; recommend seal cracks.

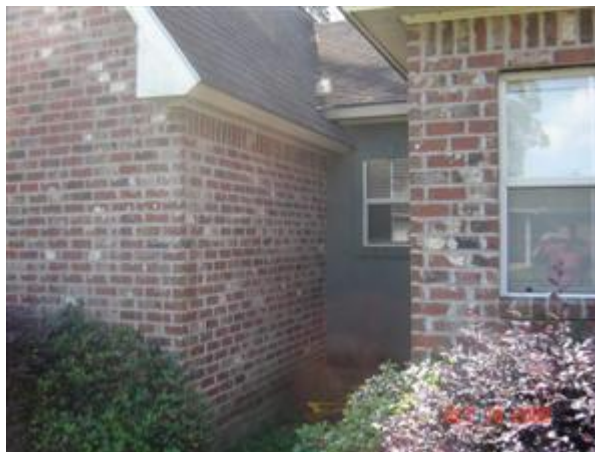
3.3 Picture 1

Fair

A negative grade slope toward the foundation allows water runoff and ponding. This condition can cause structural and/or water infiltration problems. Excessive soil/water pressures can actually cause lateral movement of the foundation, a potentially serious concern. Deficiencies must be corrected and suitable drainage conditions must be maintained in order to prevent problems. Most notable deficiency occurs in the small alcove at the front of the house. Gutters are also needed here. (see Gutter comments in Roofing section)

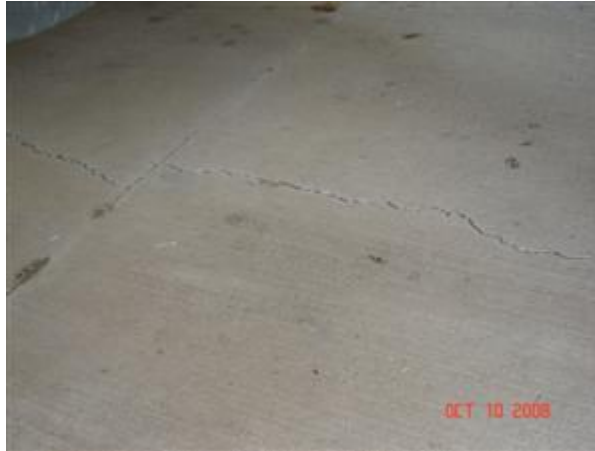
4.2 Picture 1

**Fair**

Cracking and settlement of floor slab noted; recommend seal cracks.

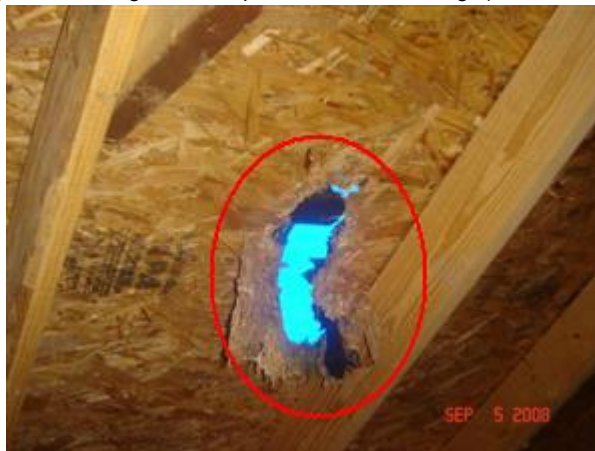
5.1 Picture 1

**Poor**

Home owner indicates storm damaged sheathing will be replaced before closing. (see Roofing Comments) Verify before closing.

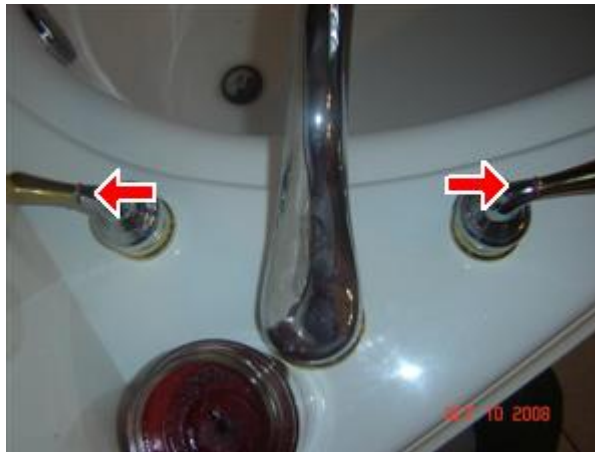
6.8.B Picture 1

A limited check of the bathtub jets indicated there was water flow and aeration. A complete evaluation of the jetted bath system or its effectiveness was not performed. Recommend review of operational and maintenance procedures with the homeowner.

Hot and cold facet handles on the tub (blue trim ring/red trim ring) are backwards from the hot and cold water sources. A simple switch of handles is recommended to avoid someone turning the wrong handle.

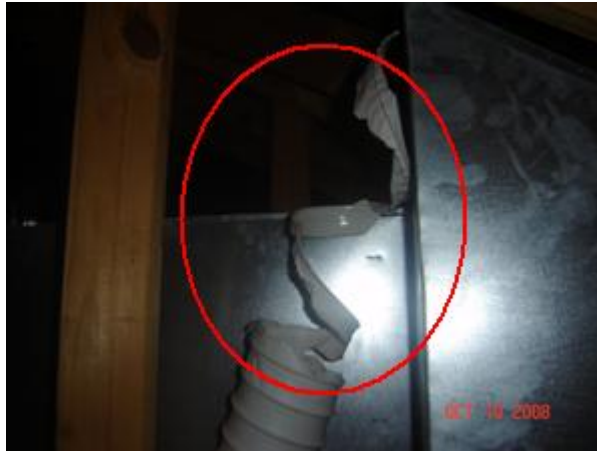
6.4.C Picture 1

Poor

The bathroom exhaust fan should discharge directly to the exterior to prevent excess moisture concerns in the house or attic area. The exhaust fan duct in the attic is torn in half therefore venting directly into the attic. Recommend repairing/replacing the exhaust duct extension to the original discharge point.
