1234 Any St.
Anytown CO 80132

Integrity Home Inspections

Inspection Date: 5/18/2009

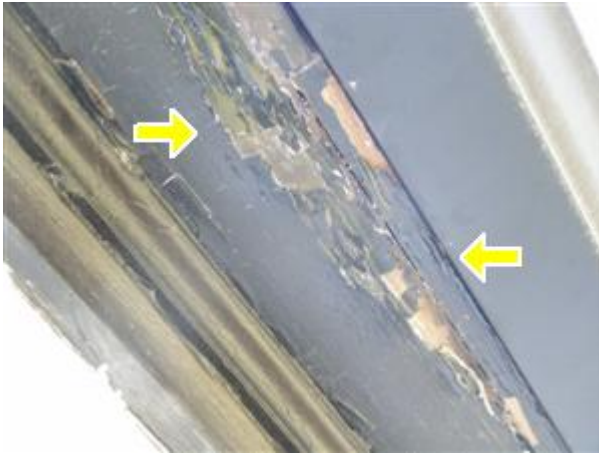
1.2 Picture 1

Fair

Wood rought exposed due to water penetration. Further evaluation by licensed contractor needed.

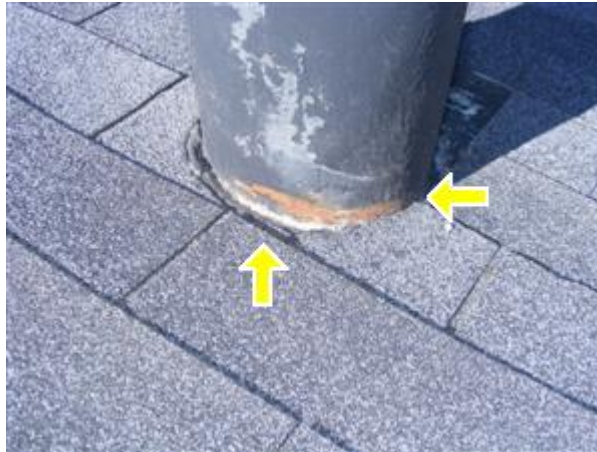
1.6 Picture 1

Fair

Steel flange is rusted and can cause leakage. Calking is needed to prevent water penetration.

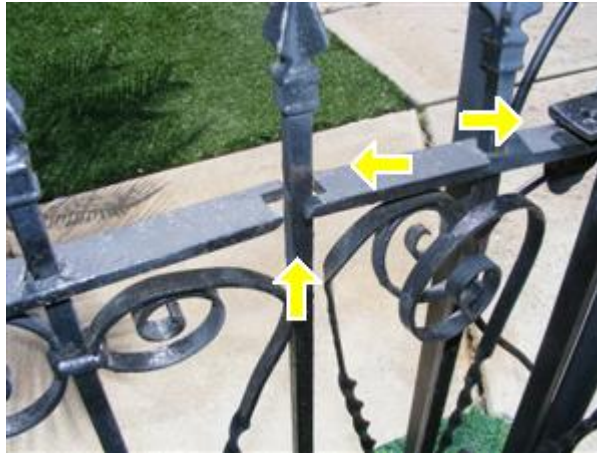
2.3 Picture 1

Fair

Front porch railing broken and bolt missing that causes a safety hazard.

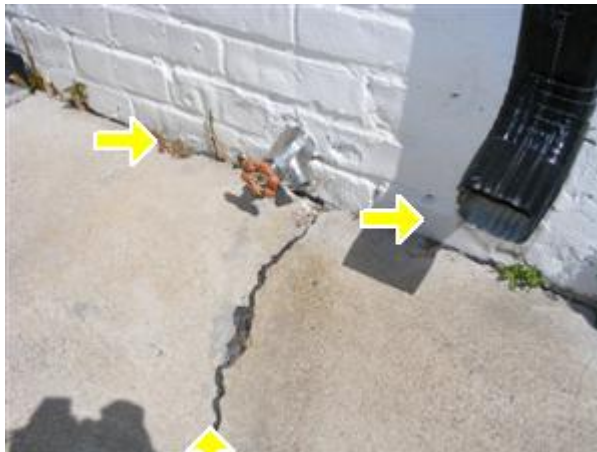
2.10 Picture 1

Fair

Water penetration at water bib house outlet on left side of house along with downspout should be caulked and downspout redigested away from the foundation.

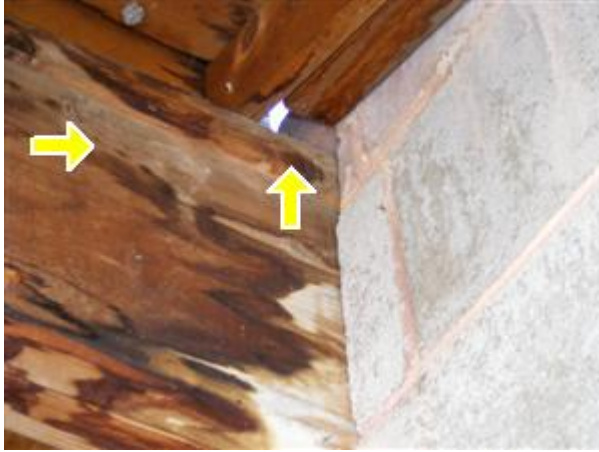
4.1 Picture 1

Exposed outside light through garage roof with water penetration. Further evaluation by a roofing contractor needed. (pic1)

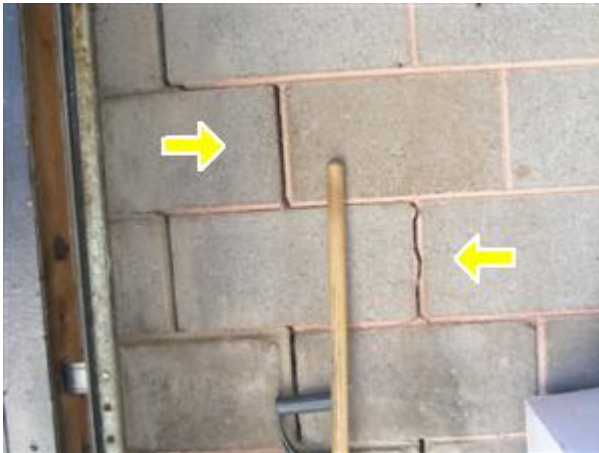
4.4 Picture 1

Poor/Defective

Block walls show movement. Further evaluation by a licensed contractor needed.(Pic1) (Pic 2)

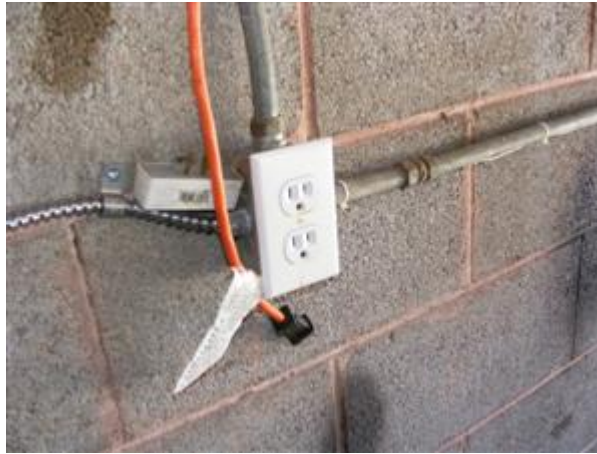
4.6 Picture 1

Fair

Garage receptacle not grounded. Repair as needed.

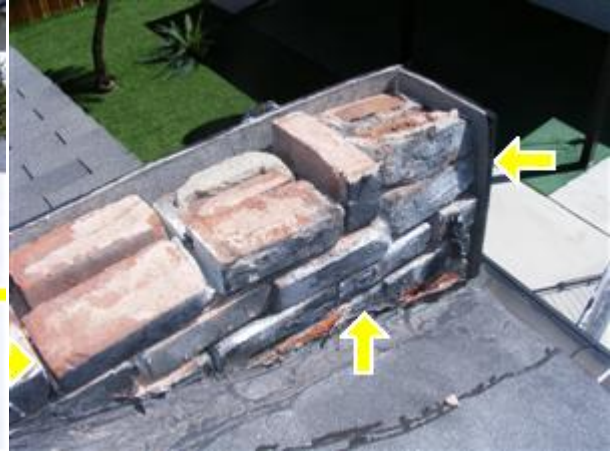
4.7 Picture 2

Loose brick on roof causes water penetration and leaks into garage. (pic2)

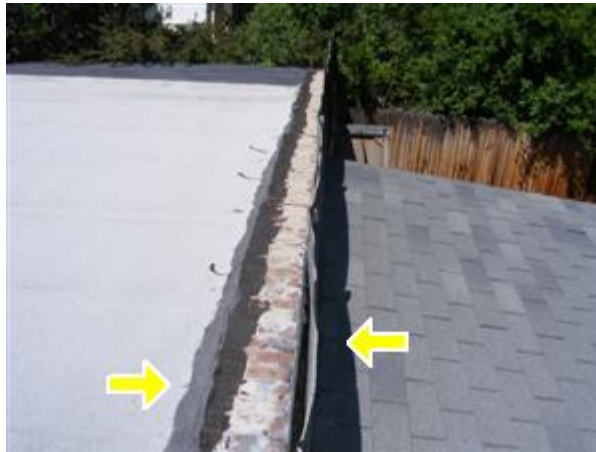
4.7 Picture 3

wood siding on roof is warped and deteriorated. needs repair. (pic3)

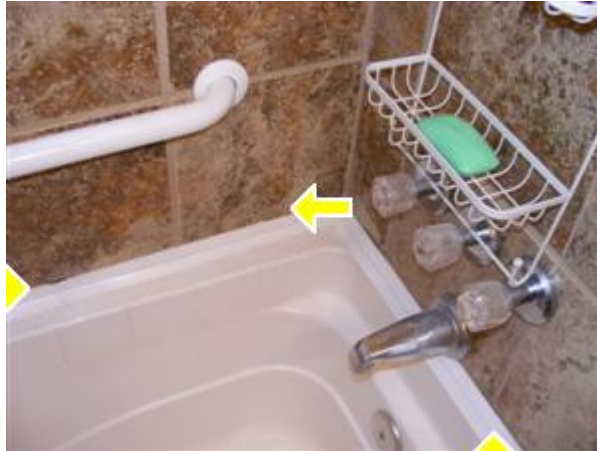
6.4.A Picture 1

Fair

Water seal around bathtub needs to be replaced to avoid water penetration

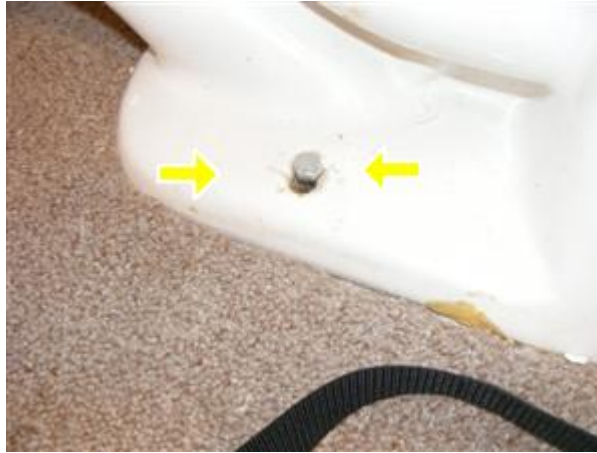
6.1.B Picture 1

Fair

Toilet is not securely attached to the floor properly, which can cause leakage and damage to the subflooring, etc.; tighten or remove toilet to inspect subflooring as desired and repair as necessary.

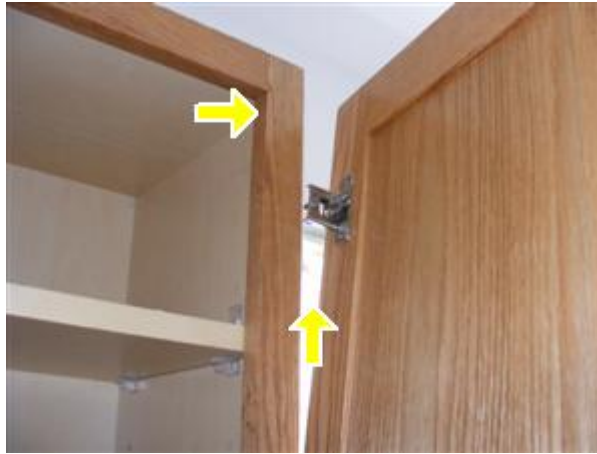
7.0 Picture 1

Fair

Cabinetry door screws loose. Needs repairs.

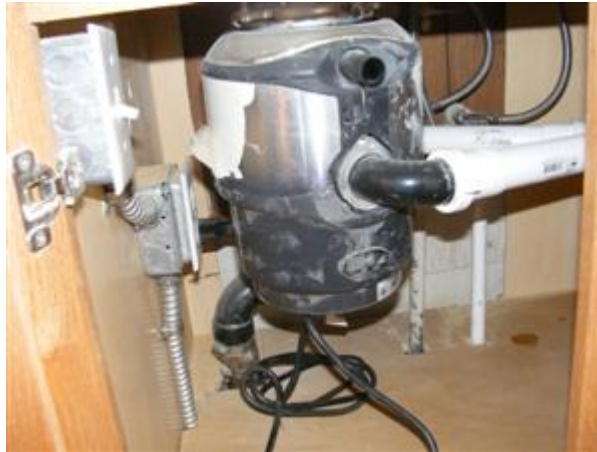
7.7 Picture 1

Poor/Defective

Garbage disposal has foreign objects in it that prevents proper usage. Repairs needed.

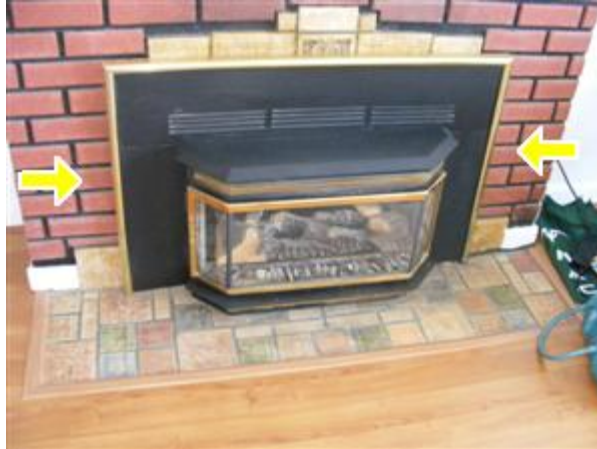
8.6 Picture 1

Poor/Defective

Electric and gas fire place does not work and fumes from fireplace can enter into living space. Further evaluation by a licensed contractor needed.

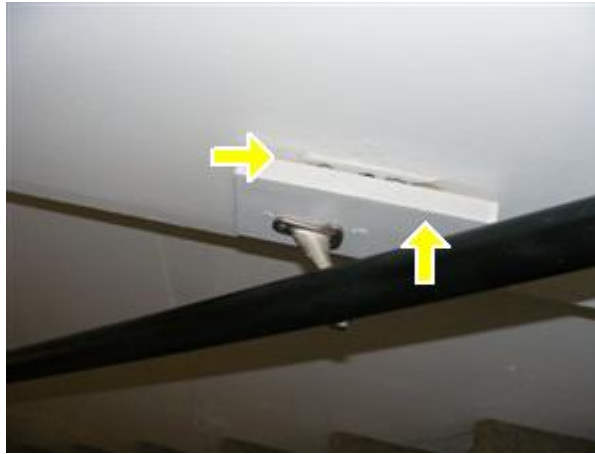
9.0 Picture 1

Poor/Defective

Railing loose and poses a safety hazard. Repairs needed.

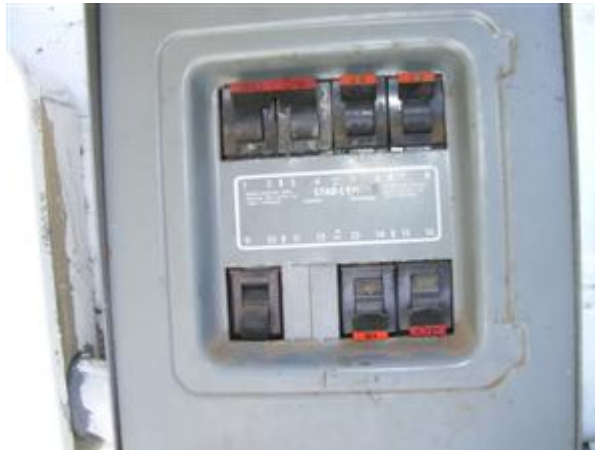
11.4 Picture 1

Breakers are not labeled.

Older panel observed. As panels age, the likelihood for malfunction increases.

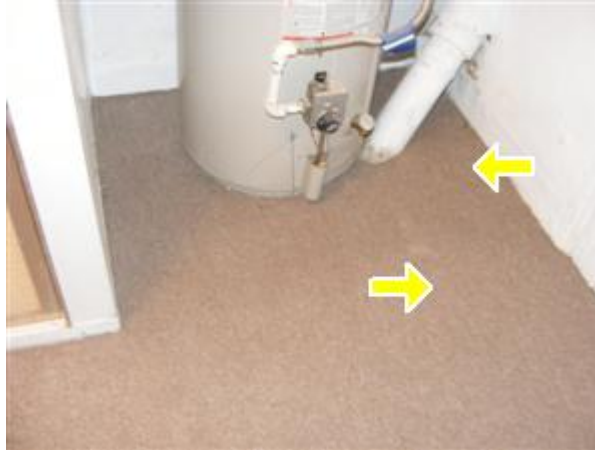
15.3 Picture 1

Fair

Discharge tube on the TPRV valve not present. Add appropriate piping (typically 3/4" pipe) to within 6" of the floor to avoid accidental burn.
