EXPRESS REPORT

Report ID: Sample Report

Property Address:
1234 Somewhere St.
Anytown, FL 55555

HouseMaster Home Inspections
Inspector: Steve Lightcap

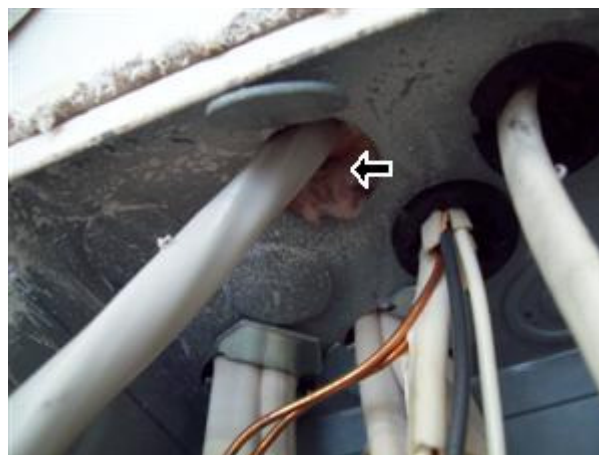
9.3 DISTRIBUTION PANEL Picture 1

•					9.0	SERVICE / ENTRANCE LINE
•					9.1	SERVICE GROUNDING PROVISIONS
•					9.2	MAIN DISCONNECT(S)
	•				9.3	DISTRIBUTION PANEL Wire coming into electric panel with out proper grommet, repair.(Picture 1)
•					9.4	DEVICES
•					9.5	WIRING / CONDUCTORS Evaluation of ancillary, low voltage electric or electronic equipment (e.g., TV, doorbell, computer, cable, lightning protection, surge protection, low voltage lighting, intercoms, site lighting, alarms etc.) is not performed as part of a standard home inspection.
•					9.6	GFCI TEST

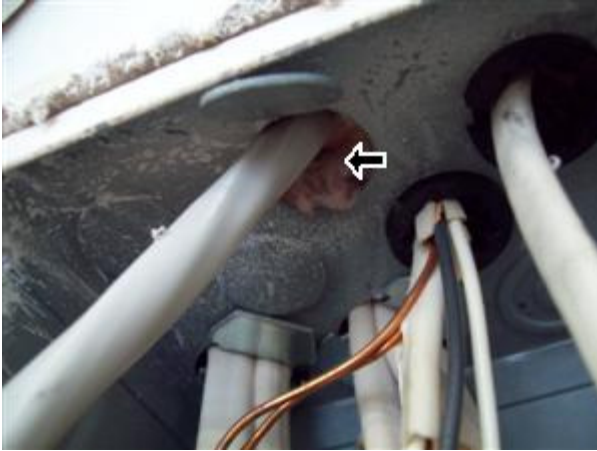
9.3 Picture 1

ELECTRIC SYSTEM**9.3 DISTRIBUTION PANEL****Fair**

Wire coming into electric panel with out proper grommet, repair.(Picture 1)
