1234 Somewhere St.

HouseMaster

Inspection Date: 1/1/2010

INSPECTION INFORMATION

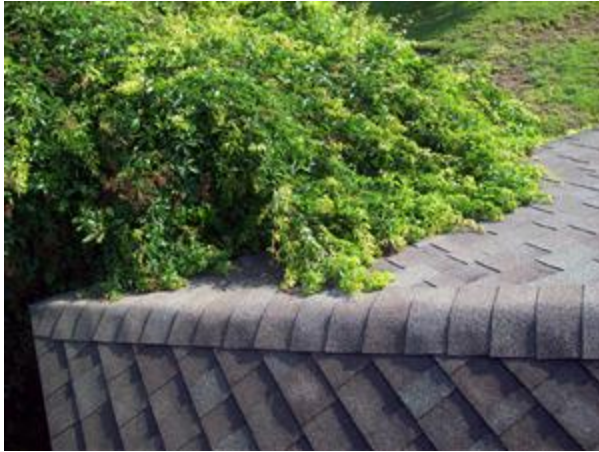
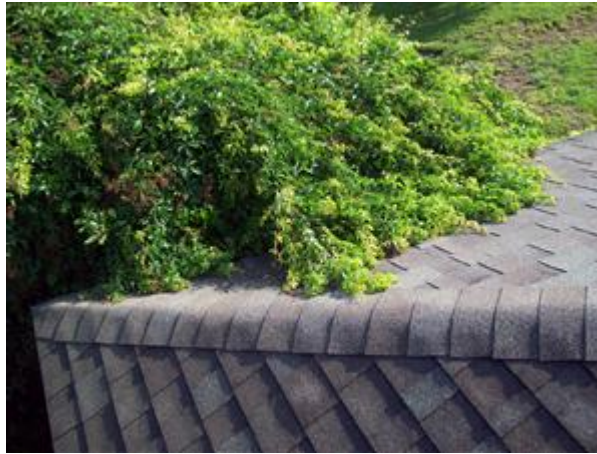
1.0 -----ROOF #1----- Picture 1

(Picture 1) Trees rubbing roof at front left, trim branches back.

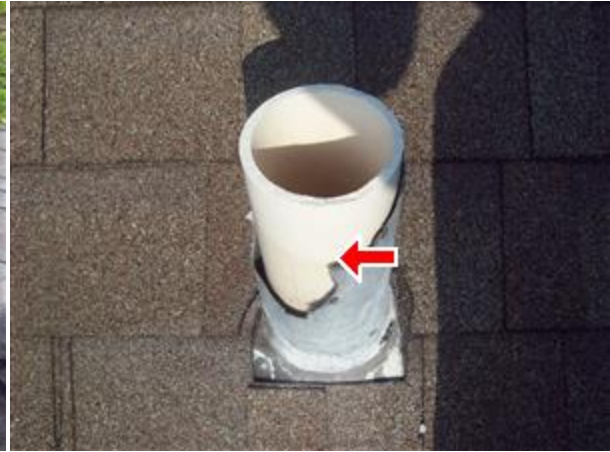
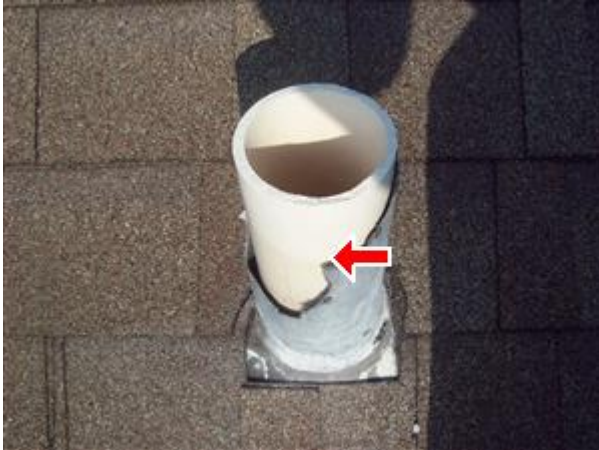
1.4 PLUMBING STACKS Picture 1

(Picture 1)(Picture 2)Damaged/deteriorated covering at 2 plumbing stacks, replace lead coverings.

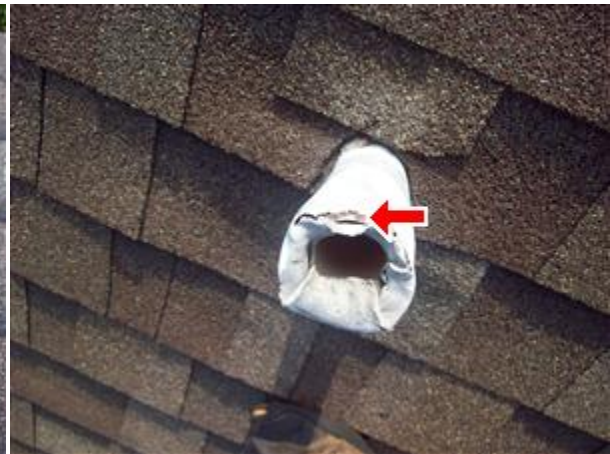
1.4 PLUMBING STACKS Picture 3

(Picture 3)Damaged/deteriorated covering at top of right side plumbing stack, reseal.

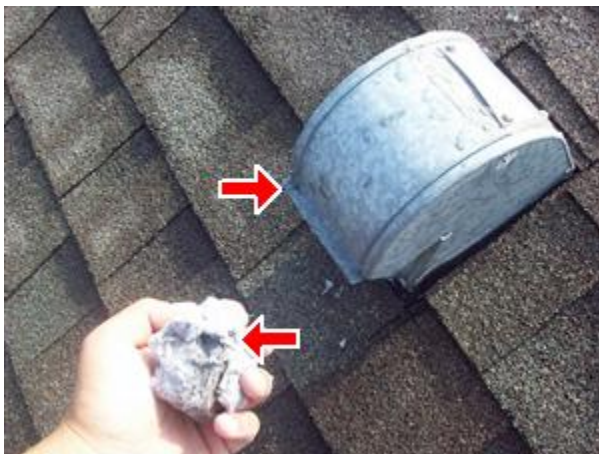
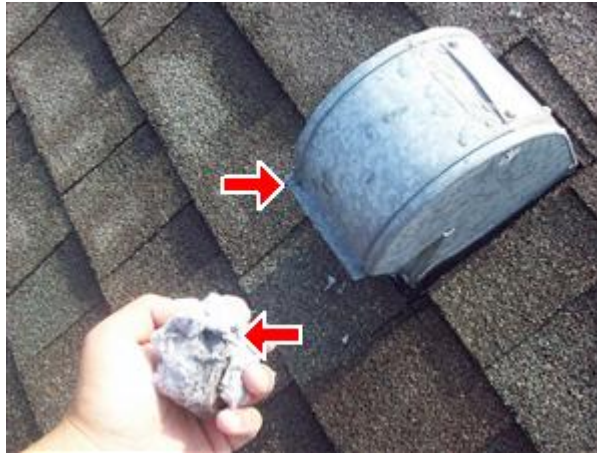
1.5 DRYER VENT HOOD Picture 1

(Picture 1)Due to large amount of lint removed from dryer vent hood at roof, have entire vent cleaned.

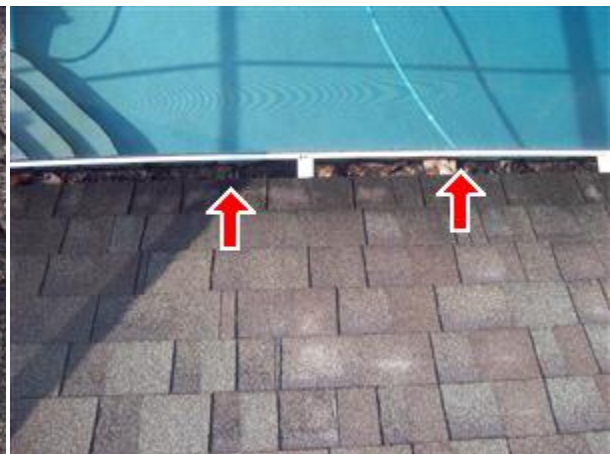
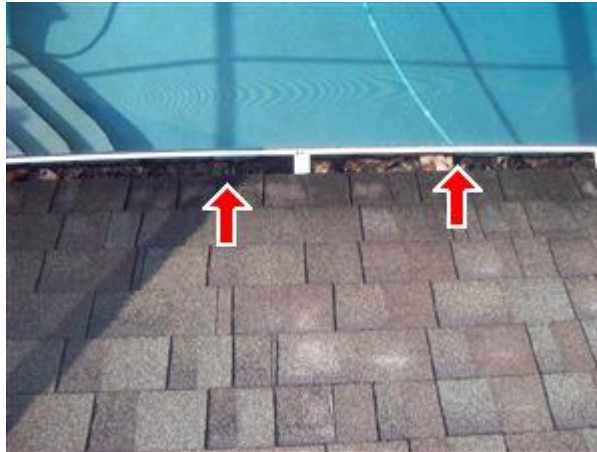
1.6 RAIN GUTTERS / EAVETROUGHS Picture 1

(Picture 1)Debris in gutters, clear for proper function.

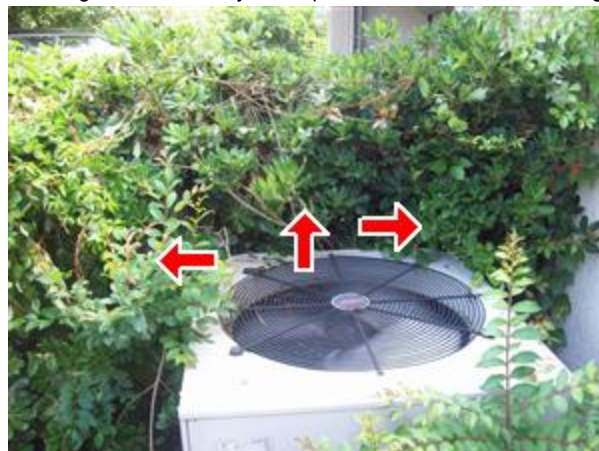
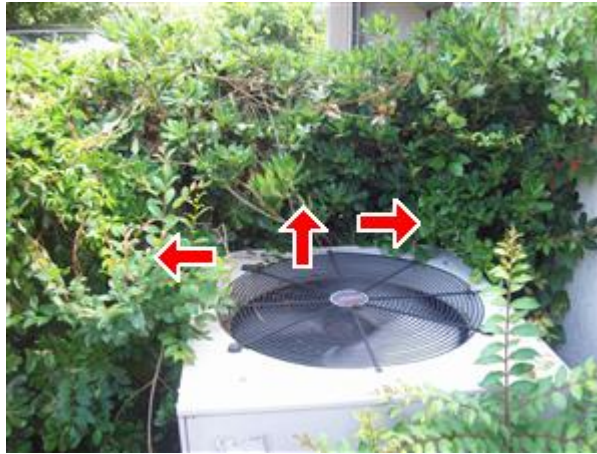
10.1 OUTDOOR UNIT(S) Picture 1

Exterior A/C compressor has vegetation growing around unit, trim back for proper function.(Picture 1)
