Report ID:

Property Address:

Broken Arrow, OK 74012

Inspection Date: 8/12/2008

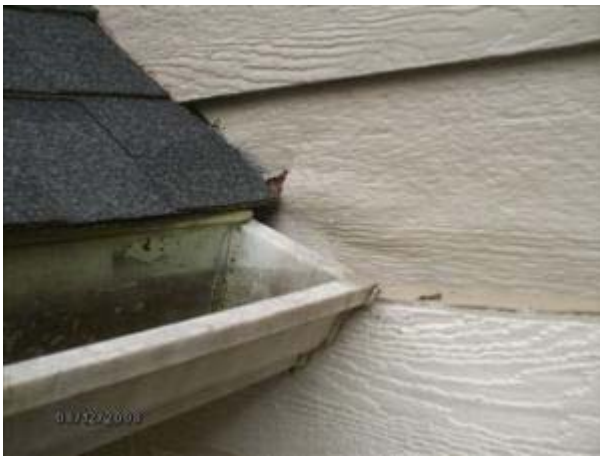
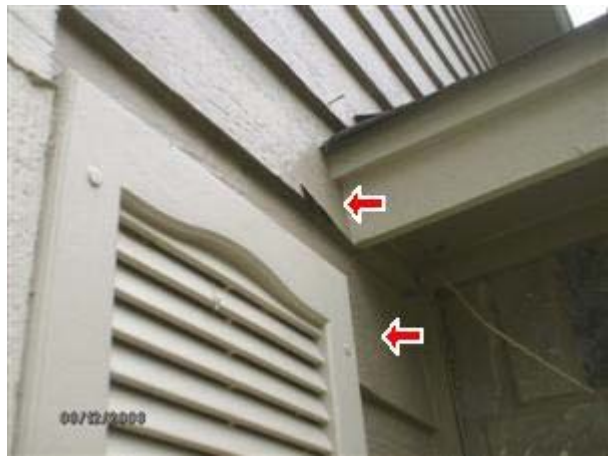
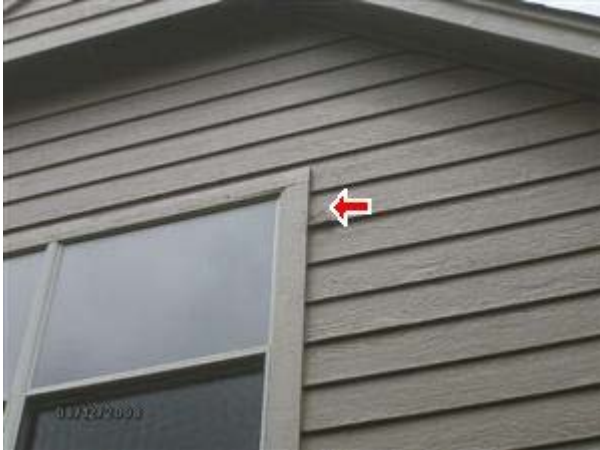
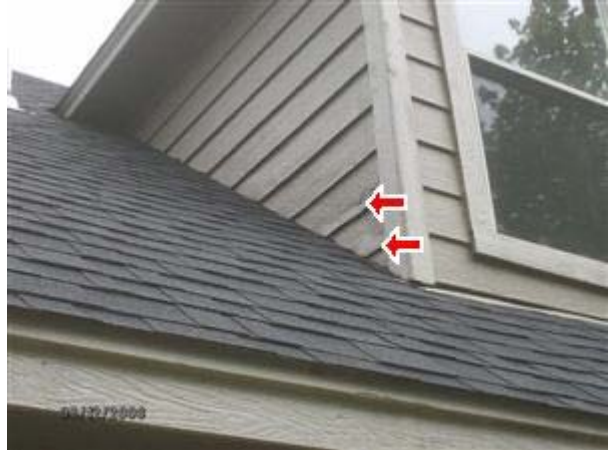
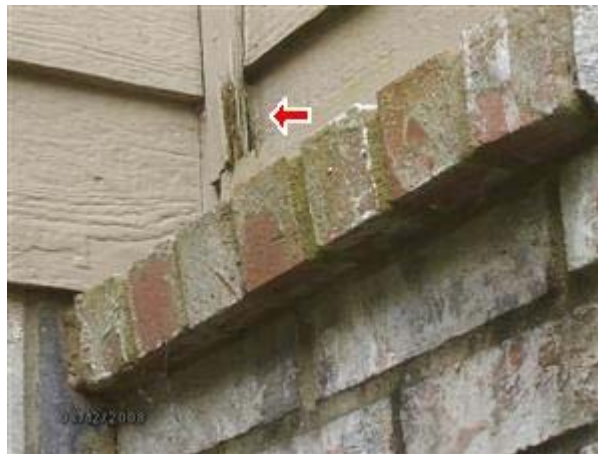
3.1 SIDING 2 Picture 1

3. East of the gable window on the South side
4. North side of the dormer on the rear of the house
5. Bottom of the patio cover at the bottom of the roof line
6. East side of the chimney at the brick ledge.

Siding is composition hardboard and easily damaged if water penetration occurs. This material is adversely affected by moisture. Ongoing homeowner maintenance requires immediate sealing and painting on notice of any exposed composition. Failure to paint and seal exposed areas will most likely result in rotting siding that will have to be replaced.

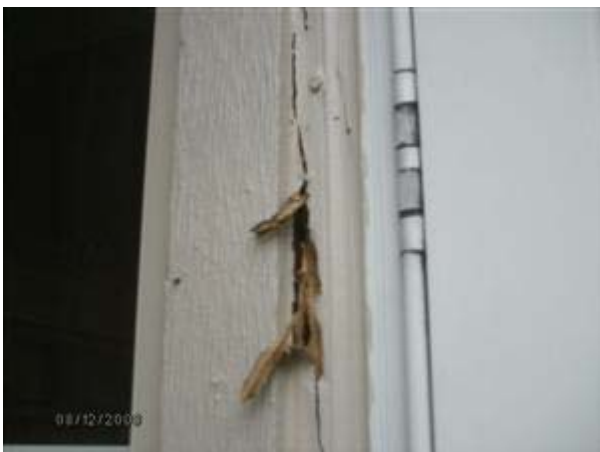
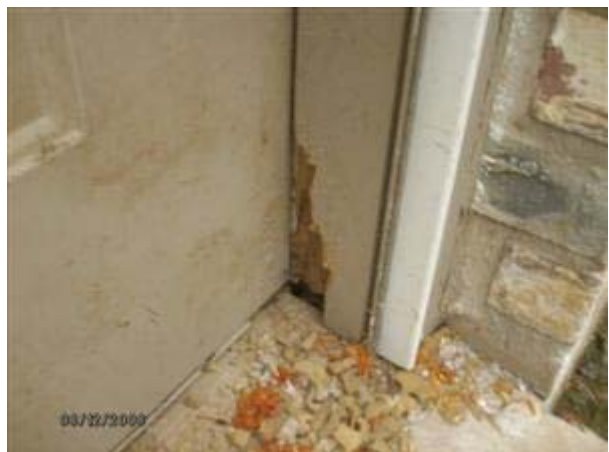
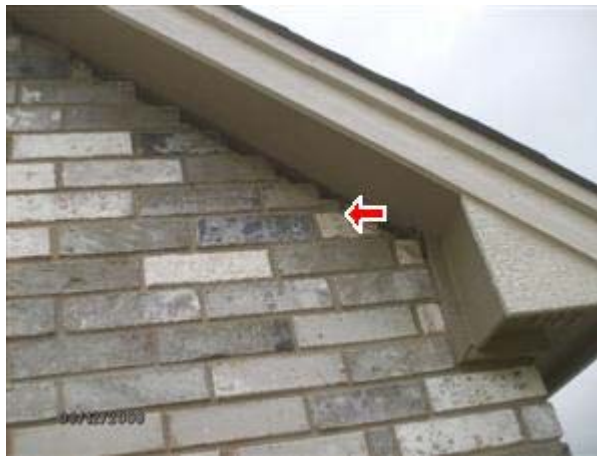
3.2 TRIM Picture 1

Wood decay at the following areas, replace affected materials:

1. Front door jamb (termite damage)
2. Rear service door door jamb in the garage
3. Bottom of South garage door opening
4. East side of the chimney at the brick ledge

Trim board on the 45 degree brick angle over the North garage door has fallen off.

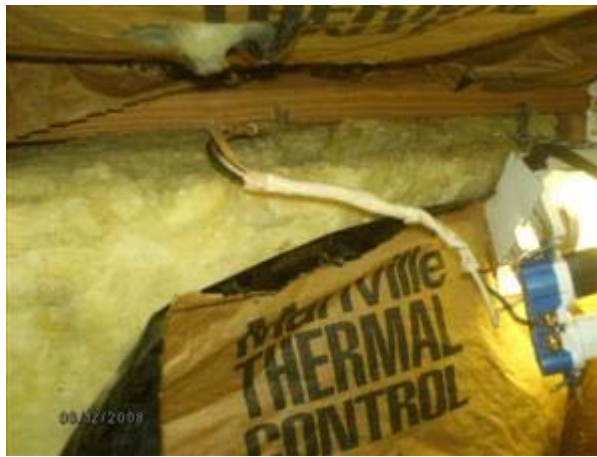
10.4 DEVICES Picture 1

1. Exposed wiring and outlet in the ceiling of the room being finished out upstairs.
2. The stairway lights are not functioning.
3. Reversed polarity found on the outlets at the bottom of the stairs. This is a potential shock hazard.

Have an electrician correct the following:

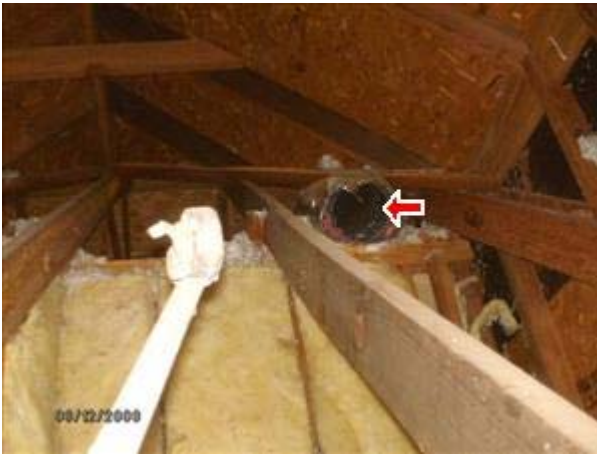
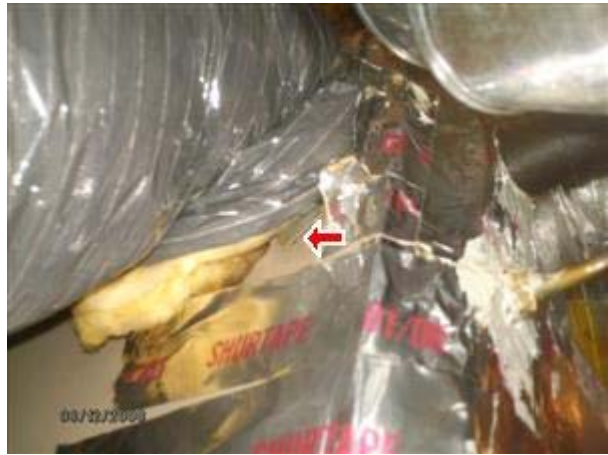
11.8 DISTRIBUTION SYSTEM Picture 1

The duct system has several openings where air is escaping and not being properly delivered to tall the registers for the downstairs system. Air is escaping from the plenum connection of the West duct run on the upstairs furnace. Have an HVAC contractor correct all ductwork issues.

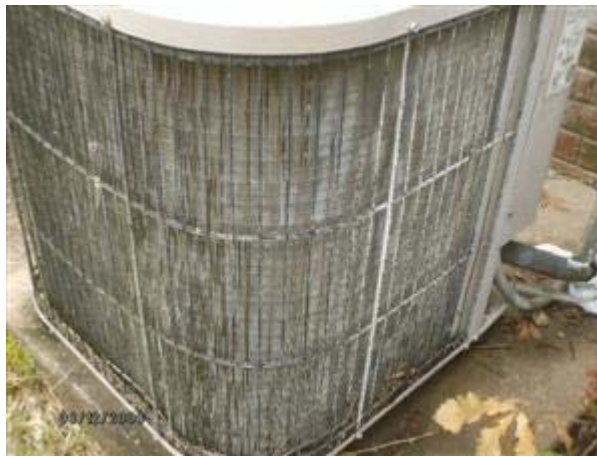
12.2 OUTDOOR UNIT(S) Picture 1

The aluminum fins on the smaller condensing unit are about 60% smashed. This will restrict the airflow through the coil and cause the system to not operate properly. Have an HVAC contractor comb the fins.

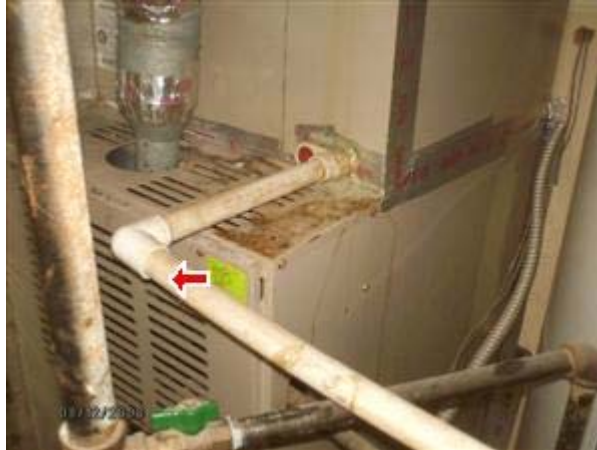
12.3 CONDENSATE PROVISIONS Picture 1

The PVC line at the downstairs furnace is not glued at the joints, have glued so it does not come apart.
