Report ID: THIS IS SAMPLE REPORT ONLY

Property Address:  
123 Anywhere Street  
Chapel Hill, NC 27517

Cornerstone Home Inspection Service, LLC dba HouseMaster  
Inspector: C. Garrett "Garry" Walker III NC LIC # 1551

1289 N. Fordham Blvd  
Suite A-109  
Chapel Hill NC 27514  
919-403-9675  
Inspection Date: 3/12/2007

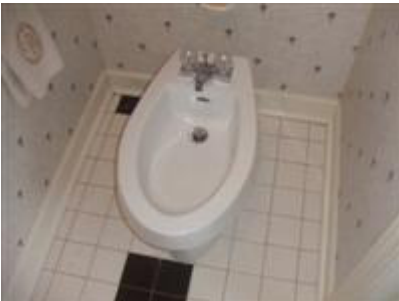
8.9.A Picture 1

Bidet can not be properly operated. A visual review only was performed. Check function prior to closing.

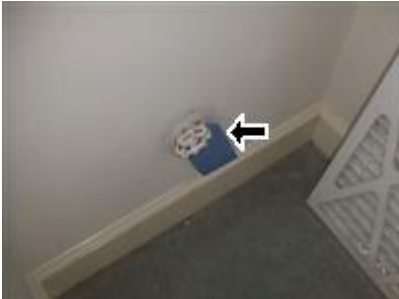
11.0 Picture 1

The main shut off is the green knob located in front main level bedroom closet.
