1234 Any St.
Anytown CO 80132

Integrity Home Inspections

Inspection Date: 5/18/2009

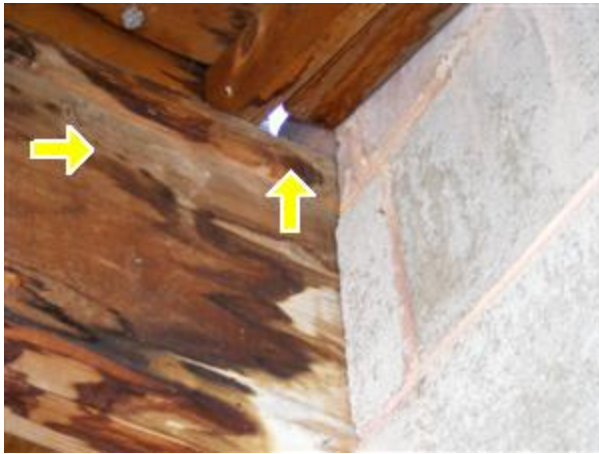
4.1 EXPOSED FRAMING Picture 1

•						4.0 FLOOR SLAB Not inspected Due to garage door not being able to open and there is no side access door.
	•					4.1 EXPOSED FRAMING Exposed outside light through garage roof with water penetration. Further evaluation by a roofing contractor needed. (pic1) Water
•						4.2 FOUNDATION
			•			4.3 ATTIC VENTILATION
	•					4.4 WALLS / CEILINGS Block walls show movement. Further evaluation by a licensed contractor needed.(Pic1) (Pic 2)
	•					4.5 VEHICLE DOOR(S) Lock hard to open and t lock sticks.
•						4.6 ELECTRIC / GFCI Garage receptacle not grounded. Repair as needed.
	•					4.7 ROOFING Tree contact will lesson roof life. Trim as needed. (pic 1) Loose brick on roof causes water penetration and leaks into garage. (pic2) wood siding on roof is warped and deteriorated. needs repair. (pic3)

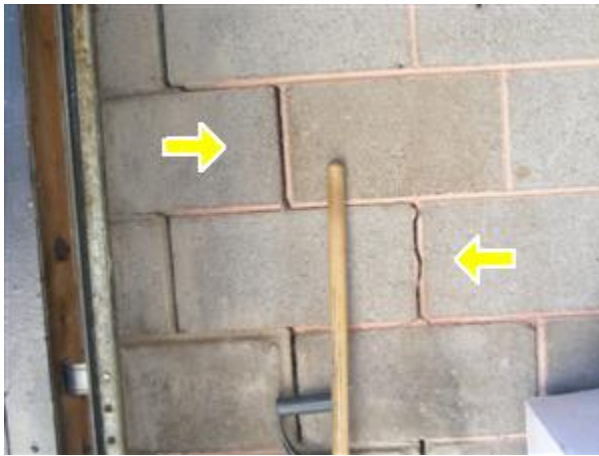
4.4 WALLS / CEILINGS Picture 1

Block walls show movement. Further evaluation by a licensed contractor needed.(Pic1) (Pic 2)

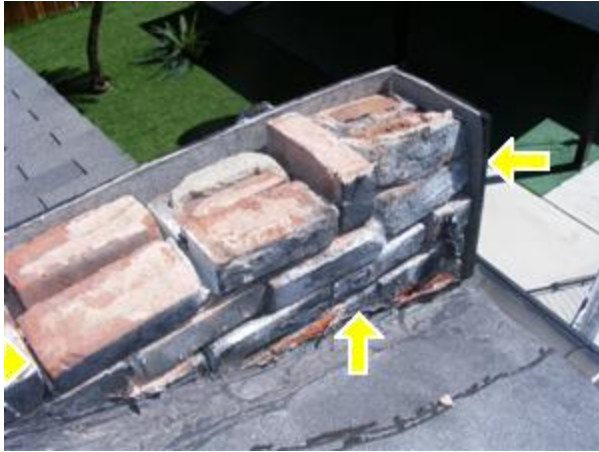
4.7 ROOFING Picture 2

Loose brick on roof causes water penetration and leaks into garage. (pic2)

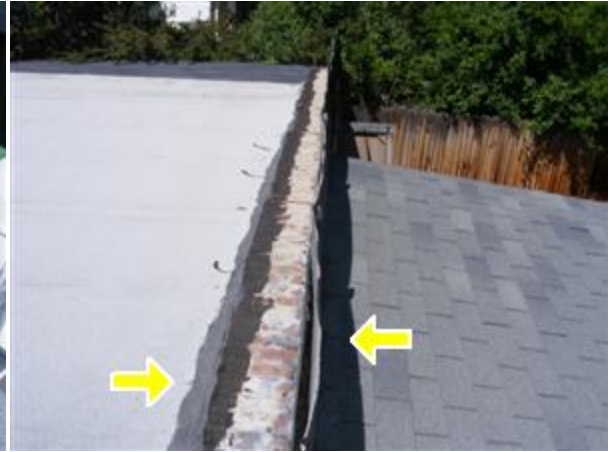
4.7 ROOFING Picture 3

wood siding on roof is warped and deteriorated. needs repair. (pic3)
